# **Asbestos Assessor's Report:** **TFTA (0233) CF3 P2** **Fanning River Integration – HOUSE ONE**

The site of the works is located at Townsville Field Training Area – Fanning River Station.

The aim of this project was to carry out an asbestos and lead in paint survey on buildings and structures to ascertain if asbestos containing materials are present prior to demolition works scheduled to be carried out.

Environics, 12<sup>th</sup> June 2014 – Report Number 140612-1 Rev0

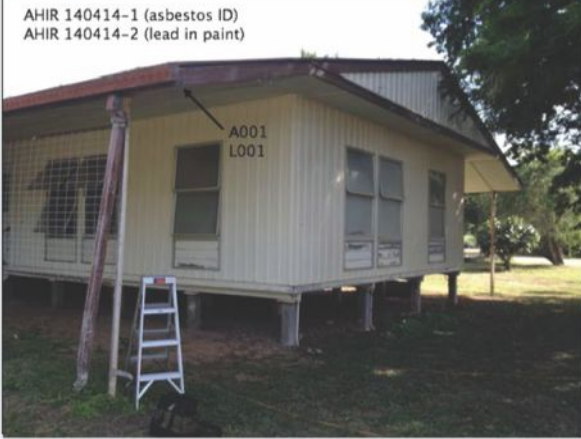
### 1.1. AHIR 140414-1 External Open Area Under Roof

Region:	NQ - NQ	Property:	TFTA (0233) CF3 P2 Fanning River Integration		Structure:	Building				
AHIR:	140414-1	Level:	Survey	Location:	GR 25.874 43.860	Space:	Ext. open area under roof			
AHIB	ACM:	asbestos cement sheet		Estate Details:	Townsville Field Training Area, Fanning River Station.		ACM MGT:	Remove for demolition		
Secondary Location:	Ceiling	Quantity (m2):	128	Occupancy In Use:	<input type="checkbox"/> No In Use:	<input checked="" type="checkbox"/>	Accessibility - Accessible:	<input type="checkbox"/> Inaccessible:	<input type="checkbox"/>	
Application:	Lining	Control - Encapsulate:	<input type="checkbox"/> Leave and Manage:	<input type="checkbox"/> Remove:	<input checked="" type="checkbox"/> N/A:	<input type="checkbox"/> Other:				
ACM Status:	Detected:	<input checked="" type="checkbox"/> Friable:	<input type="checkbox"/> Bonded:	<input checked="" type="checkbox"/> Not Detected:	<input type="checkbox"/>	Labels - Applied:	<input checked="" type="checkbox"/> Remove:	<input type="checkbox"/> Required:	<input type="checkbox"/> Sample ID #:	A001

References / Attachments / Comments:										
Photo Caption: Sample location, S.E. corner Laboratory: Envirolab Services Pty Ltd										
<p>AHIR 140414-1 (asbestos ID) AHIR 140414-2 (lead in paint)</p>

<p>Cert. of Analysis: 110214 Lab. Refer: 110214-1 Environics Refer: A001</p>				<p><b>Lead in Paint</b> %w/w <input type="text"/> Area m2: <input type="text"/></p>		
<p>Asbestos Detected - Yes: <input checked="" type="checkbox"/> No: <input type="checkbox"/> Asbestos</p> <p>If Detected, What Type: Chrysotile &amp; Amosite</p> <p>Sample Description: Area m2: 128</p> <p>Pink fibre cement material</p>										
Asbestos Assessor: Lawrie Lyons (Environics)				Drawings & Illustrations

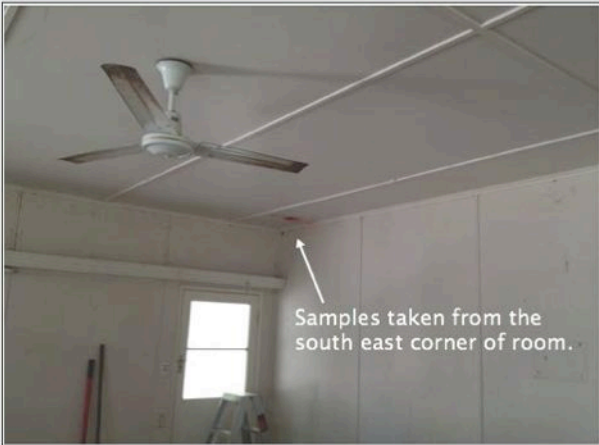
## 1.2. AHIR 140414-4 Kitchen/Dinning/Living

<b>AHIR</b>	ACM:	Bonded lining sheets	Estate Details:	Townsville Field Training Area, Fanning River Station.	ACM MGT:	Remove for demolition					
Secondary Location:	Ceiling	Quantity (m2):	34	Occupancy In Use:	<input type="checkbox"/>	No In Use:	<input checked="" type="checkbox"/>	Accessibility - Accessible:	<input type="checkbox"/>	Inaccessible:	<input type="checkbox"/>
Application:	Sheeting	Control - Encapsulate:	<input type="checkbox"/>	Leave and Manage:	<input type="checkbox"/>	Remove:	<input checked="" type="checkbox"/>	N/A:	<input type="checkbox"/>	Other:	
ACM Status:	Detected:	<input checked="" type="checkbox"/>	Labels -	Applied:	<input checked="" type="checkbox"/>	Remove:	<input type="checkbox"/>	Required:	<input type="checkbox"/>	Sample ID #	A002
Friable:	<input type="checkbox"/>	Bonded:	<input checked="" type="checkbox"/>	Not Detected:	<input type="checkbox"/>	References / Attachments / Comments:

Condition:	Fair	Internal ceilings of the kitchen, dinning area, living room, and walk in pantry at the northern end of the house.

Photo Caption:	Sample location, N.E. corner	Laboratory:	EnviroLab Services Pty Ltd
----------------	------------------------------	-------------	----------------------------

Cert. of Analysis:	110213	<b>Lead in Paint</b>	
Lab. Refer:	110214-2 & 3	%w/w	0.2
EnviroLab Refer:	A002	Area m2:	52

Asbestos Detected - Yes:	<input checked="" type="checkbox"/>	No:	<input type="checkbox"/>	<b>Asbestos</b>
If Detected, What Type:	Chrysotile & Amosite			
Sample Description:	Area m2: 34			
Grey compressed fibre cement material

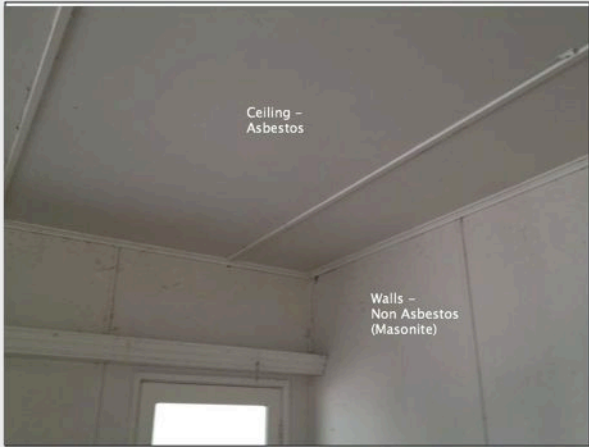
### 1.3. AHIR 140414-5 Walls, Kitchen, Dining & Living

Photo Caption:	Sample location, N.E. corner		Laboratory:				Not applicable

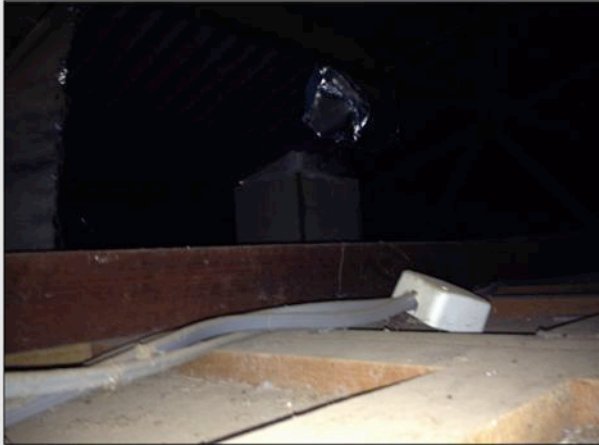
## 1.4. AHIR 140414-6A Ceiling Space

Condition:	Fair

Photo Caption:	Laboratory:
Ceiling Space	Not applicable

If should be noted that the ceiling sheets below the ceiling space are asbestos as reported in a separate AHIR.

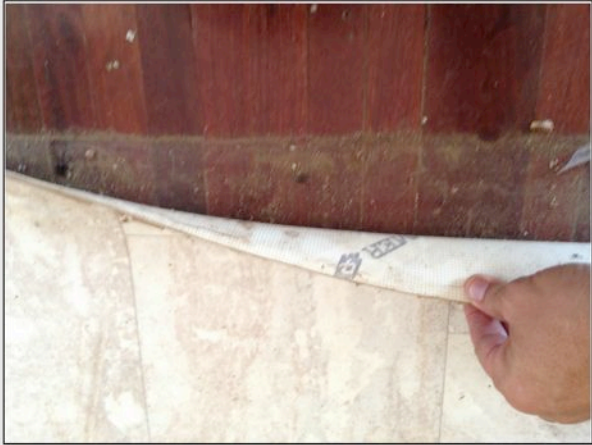
Photo Caption:	Flooring material	Laboratory:	Not applicable
----------------	-------------------	-------------	----------------

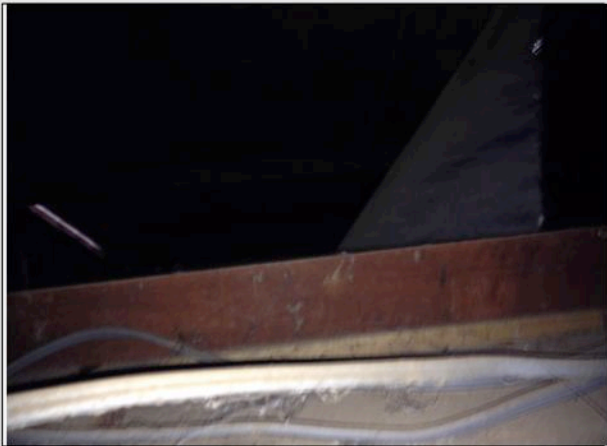
## 1.7. AHIR 140414-9 Ceiling Space Inspection(s)

Photo Caption:	Flooring material	Laboratory:	Not applicable
----------------	-------------------	-------------	----------------

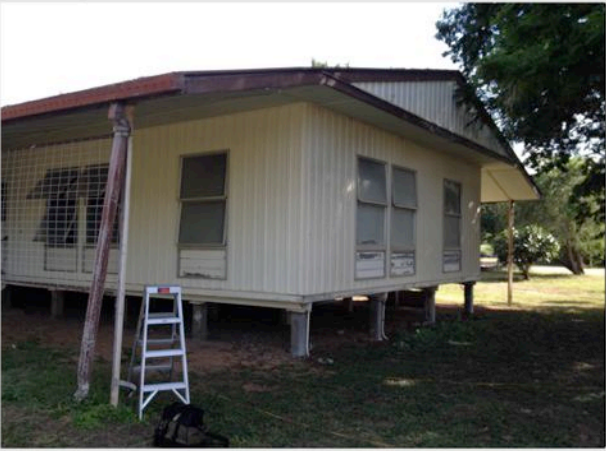
## 1.8. AHIR 140414-10 External Wall Cladding

Region:	NQ - NQ	Property:	TFTA (0233) CF3 P2 Fanning River Integration		Structure:	House 1	
AHIR:	140414-10	Level:	Survey	Location:	GR 25.883 43.850	Space:	External Area
AHIR	ACM:		Estate Details: Townsville Field Training Area, Fanning River Station.		ACM MGT:		Remove for demolition
Secondary Location:	Walls		Quantity (m2):		Occupancy In Use:	<input type="checkbox"/>	No In Use: <input checked="" type="checkbox"/>
Application:	Cladding		Control - Encapsulate:	<input type="checkbox"/>	Leave and Manage:	<input type="checkbox"/>	Remove: <input type="checkbox"/>
ACM Status:	Detected: <input type="checkbox"/>		Labels -	Appixed: <input type="checkbox"/>	Remove: <input type="checkbox"/>	Required: <input type="checkbox"/>	Sample ID #: <input type="text"/>
Friable:	<input type="checkbox"/>	Bonded:	<input type="checkbox"/>	Not Detected:	<input type="checkbox"/>	References / Attachments / Comments:	
Condition:	Fair		Check of external walls - north, east, south, and west found to be tin coated with lead based paint (refer AHIR 140414-3)

Photo Caption:	External Cladding		Laboratory:		Not applicable

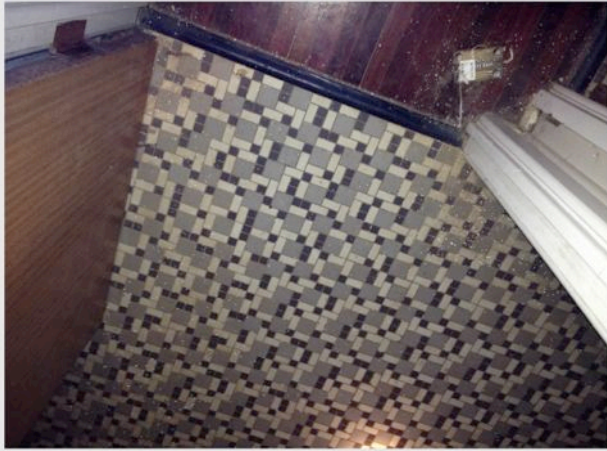
## 1.9. AHIR 140414-11 Bathroom Ceramic Tiles

Photo Caption:		Ceramic Flooring Tiles		Laboratory:				Not applicable

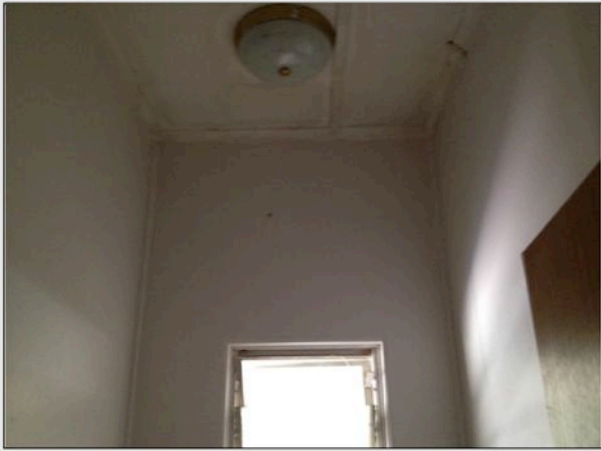
## 1.10. AHIR 140414-12A Bathroom/Toilet Walls & Ceiling

Photo Caption:	Ceilings and Walls	Laboratory:	Not applicable
----------------	--------------------	-------------	----------------

Asbestos Detected - Yes:	<input type="checkbox"/>	No:	<input checked="" type="checkbox"/>	<b>Asbestos</b>
If Detected, What Type:				
Sample Description:			Area m2:	
Not applicable

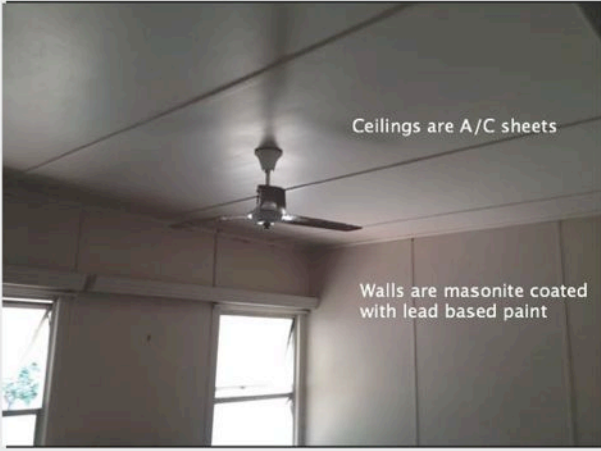
## 1.11. AHIR 140414-13A Bedroom 1 Walls, Floors, Ceiling

Photo Caption:	Ceilings and Walls	Laboratory:	EnviroLab Services Pty Ltd
----------------	--------------------	-------------	----------------------------

Ceilings are A/C sheets

Walls are masonite coated with lead based paint

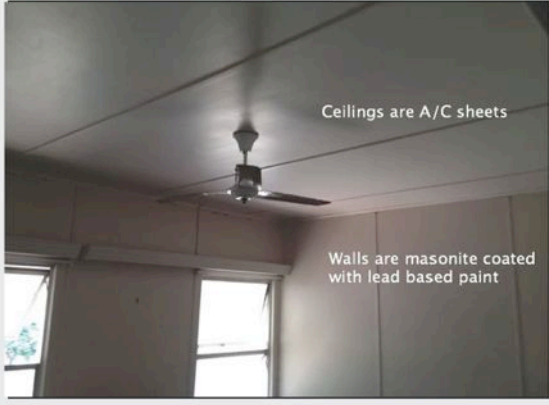
## AHIR 140414B Bedroom 2 Walls and Ceiling

Masonite Timber walls and Timber floors Ceiling is A/C sheets same as Kitchen/Living Area					
Photo Caption:	Ceilings and Walls	Laboratory:	Envirolab Services Pty Ltd

Ceilings are A/C sheets

Walls are masonite coated with lead based paint

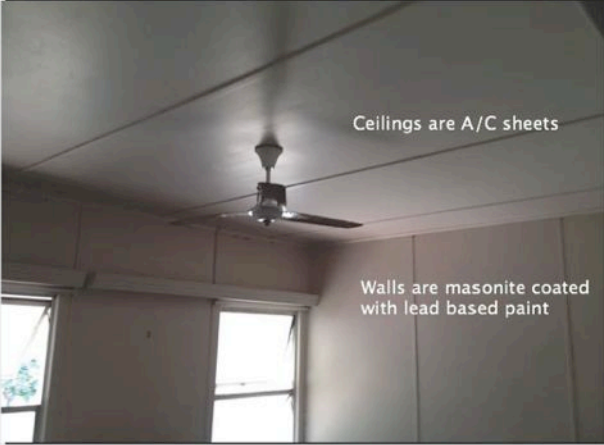
## 1.12. AHIR 140414-15A Bedroom 3 Walls, Ceiling, Floors

Photo Caption: Ceilings and Walls	Laboratory: Envirolab Services Pty Ltd
-----------------------------------	--

Cert. of Analysis:	110213	<b>Lead in Paint</b>
Lab. Refer:	110213-3	%w/w
Environics Refer:	L003	Area m2:
		0.2
		32

Asbestos Detected - Yes: <input checked="" type="checkbox"/> No: <input type="checkbox"/>	<b>Asbestos</b>
If Detected, What Type:	Chrysotile & Amosite
Sample Description:	Area m2: 12
Grey compressed fibre cement material, painted

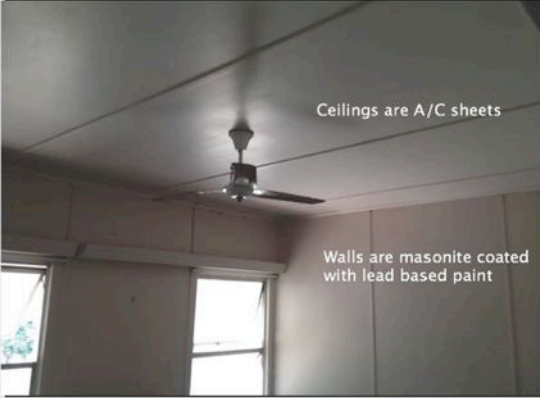
## 1.13. AHIR 140414-16A Living Quarters

Condition:	Fair	Masonite Timber walls and Timber floors partly covered with vinyl Ceiling is A/C sheets same as Kitchen/Living Area			
Photo Caption:	Ceilings and Walls	Laboratory:	Envirolab Services Pty Ltd

Cert. of Analysis:	110213	<b>Lead in Paint</b> %w/w: 0.2 Area m2: 48
Lab. Refer:	110213-3	
Envionics Refer:	L003	
Asbestos Detected - Yes: <input checked="" type="checkbox"/> No: <input type="checkbox"/> Asbestos		<b>Asbestos</b> If Detected, What Type: Chrysotile & Amosite Sample Description: Area m2: 21 Grey compressed fibre cement material, painted
If Detected, What Type:		
Sample Description:

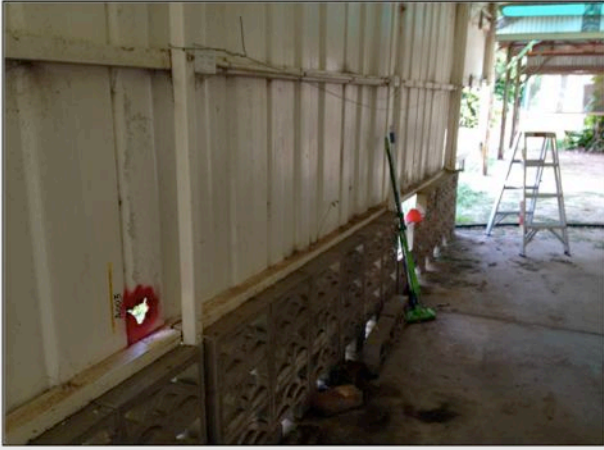
## 1.14. AHIR 140414-17 Veranda Walls

Friable: <input type="checkbox"/>	Bonded: <input checked="" type="checkbox"/>	Not Detected: <input type="checkbox"/>	References / Attachments / Comments:					
Condition:	Fair		Walls of External area under roof of veranda A/C sheet painted with the same lead based paint as elsewhere externally.					
Photo Caption:	Veranda Walls		Laboratory:	Envirolab Services Pty Ltd

Cert. of Analysis:	110213	<b>Lead in Paint</b>	
Lab. Refer:	110214-3		
Environics Refer:	A003		
		%w/w	0.2
		Area m2:	40

Asbestos Detected - Yes: <input checked="" type="checkbox"/> No: <input type="checkbox"/>	<b>Asbestos</b>
If Detected, What Type:	Chrysotile
Sample Description:	Area m2: 40
Grey compressed fibre cement material, painted

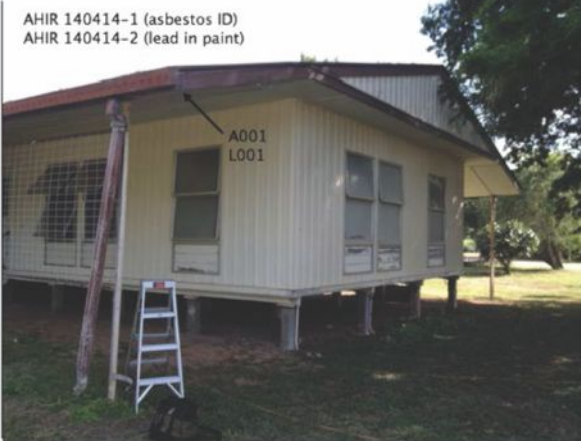
Region:	NQ - NQ	Property:	TFTA (0233) CF3 P2 Fanning River Integration		Structure:	Building		
AHIR:	140414-2	Level:	Survey	Location:	GR 25.874 43.860	Space:	Ext. open area under roof	
ACM:	Estate Details:		Townsville Field Training Area, Fanning River Station.		ACM MGT:	Remove for demolition		
Secondary Location:	Ceiling	Quantity (m2):		Occupancy In Use:	<input type="checkbox"/>	No In Use:	<input checked="" type="checkbox"/>	
Application:	Lining	Control - Encapsulate:	<input type="checkbox"/>	Leave and Manage:	<input type="checkbox"/>	Remove:	<input checked="" type="checkbox"/>	
ACM Status:	Detected: <input type="checkbox"/>	Labels -	Applied: <input checked="" type="checkbox"/>	Remove:	<input type="checkbox"/>	Required:	<input type="checkbox"/>	
Sample ID #:	L001							
References / Attachments / Comments:	Lead in paint detected							
Photo Caption:	Sample location, S.E. corner		Laboratory:					Envirolab Services Pty Ltd

Cert. of Analysis:		110213		
AHIR 140414-1 (asbestos ID) AHIR 140414-2 (lead in paint)				Lab. Refer:		110213-1		
				Enviroics Refer:		L001		
				Lead in Paint				
				%w/w		0.3		
				Area m2:		128		
				Asbestos Detected - Yes: <input type="checkbox"/> No: <input type="checkbox"/>		Asbestos		
				If Detected, What Type:				
				Sample Description:		Area m2: <input type="text"/>		
Asbestos Assessor:				Lawrie Lyons (Enviroics)				
				Drawings & Illustrations

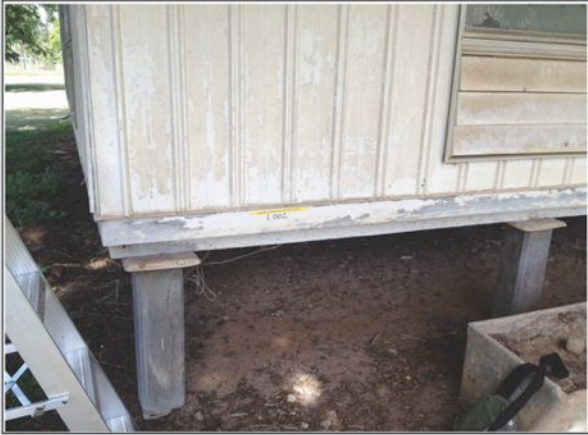
## 1.2. AHIR 140414-3 External Walls

The external walls of the house (north, east, south, & west) consist of painted tin sheeting.							
Photo Caption:	Sample location, N.E. corner			Laboratory:	Envirolab Services Pty Ltd

Cert. of Analysis:	110213		
				Lab. Refer:			
				Envionics Refer:	L002		
				<b>Lead in Paint</b> %w/w < 0.05 Area m2: 151			
				Asbestos Detected - Yes: <input type="checkbox"/> No: <input type="checkbox"/> <b>Asbestos</b> If Detected, What Type: <input type="text"/> Sample Description: <input type="text"/> Area m2: <input type="text"/>			
Asbestos Assessor: Lawrie Lyons (Envionics)				Drawings & Illustrations

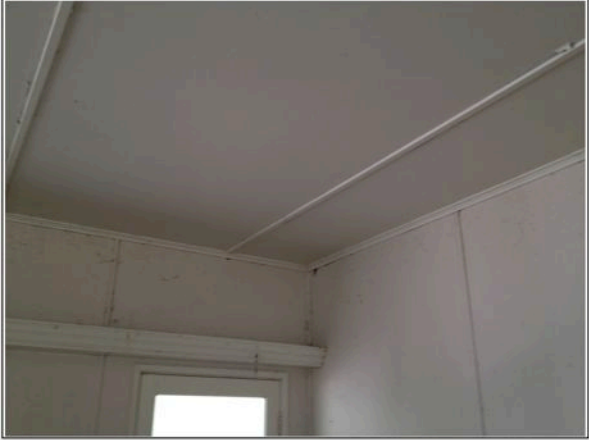
### 1.3. AHIR 140415-5 Sealant, Internal Areas

Photo Caption:	Sample location, N.E. corner	Laboratory:	Envirolab Services Pty Ltd
----------------	------------------------------	-------------	----------------------------

Cert. of Analysis:	110213	<b>Lead in Paint</b>	
Lab. Refer:	110213-3	%w/w	0.2
Envionics Refer:	L003	Area m2:	2

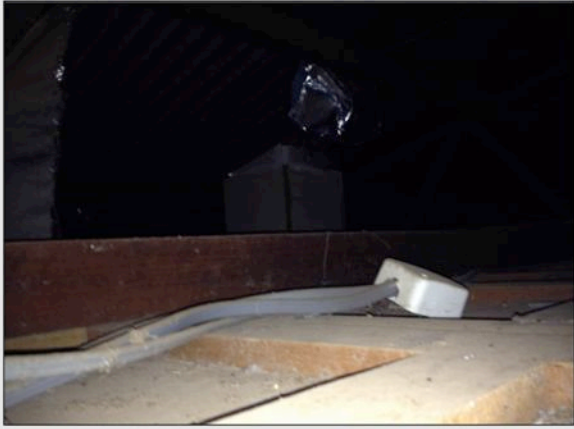
Friable: <input type="checkbox"/> Condition:		Fair		References / Attachments / Comments:			
				Ceiling space above kitchen, dining, and living area No building materials sighted that may contain asbestos or a lead/paint			
Photo Caption:		Ceiling Space		Laboratory: Not applicable

Cert. of Analysis:			
				Lab. Refer:			
				Envionics Refer:			
				<b>Lead in Paint</b> %w/w <input type="text"/> Area m2: <input type="text"/>		Asbestos Detected - Yes: <input type="checkbox"/> No: <input type="checkbox"/> <b>Asbestos</b>	
						If Detected, What Type: <input type="text"/>	
Sample Description:		Area m2: <input type="text"/>					
		Not applicable					
Asbestos Assessor: Lawrie Lyons (Envionics)				Drawings & Illustrations			
<p>The ceiling space was inspected and no building materials that may contain asbestos or lead in paint.</p> <p>If should be noted that the ceiling sheets below the ceiling space are asbestos as reported in a separate AHIR.</p>

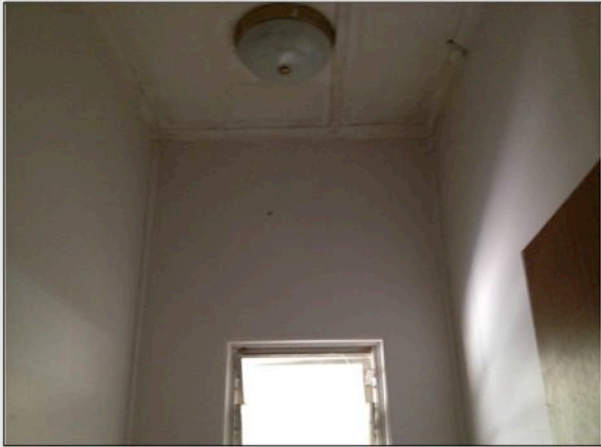
Photo Caption:	Ceilings and Walls	Laboratory:	EnviroLab Services Pty Ltd
----------------	--------------------	-------------	----------------------------

Cert. of Analysis:	110213	<b>Lead in Paint</b>	
Lab. Refer:	110213-4	%w/w	0.1
Envionics Refer:	L004	Area m2:	14

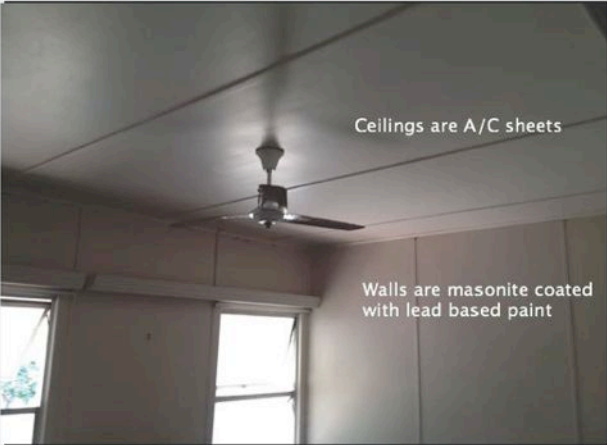
## 1.6. AHIR 140414-13B Bedroom 1 Walls & Ceiling

Photo Caption:	Ceilings and Walls	Laboratory:	EnviroLab Services Pty Ltd
----------------	--------------------	-------------	----------------------------

Cert. of Analysis:	110213	Lead in Paint
Lab. Refer:	110213-3	
EnviroLab Refer:	L003	
%w/w	0.2	Area m2: 62
Area m2:	62
