Asbestos Assessor's Report:

TFTA (0233) CF3 P2

Fanning River Integration – COTTAGE ONE

Environics, 12th June 2014 – Report Number 140612-2 Rev0

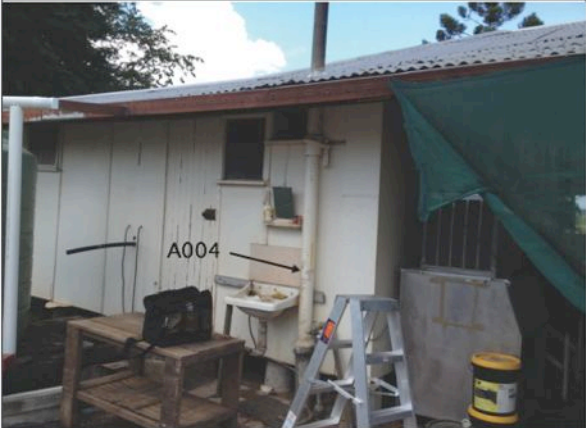
1.1. AHIR 140414-18 A/C Stand Pipe

Region:	NQ - NQ	Property:	TFTA (0233) CF3 P2 Fanning River Integration		Structure:	Cottage 1					
AHIR:	14041418	Level:	Survey	Location:	GR 25.883 43.850	Space:	External Area				
AHIR:	ACM:	A/C pipe		Estate Details:	Townsville Field Training Area, Fanning River Station.		ACM MGT:	Remove for demolition			
Secondary Location:	North West	Quantity (m2):	4	Occupancy In Use:	<input type="checkbox"/>	No In Use:	<input checked="" type="checkbox"/>	Accessibility - Accessible:	<input checked="" type="checkbox"/>	Inaccessible:	<input type="checkbox"/>
Application:	Utility	Control - Encapsulate:	<input type="checkbox"/>	Leave and Manage:	<input type="checkbox"/>	Remove:	<input checked="" type="checkbox"/>	N/A:	<input type="checkbox"/>	Other:	
ACM Status:	Detected:	<input checked="" type="checkbox"/>	Labels -	Applied:	<input checked="" type="checkbox"/>	Remove:	<input type="checkbox"/>	Required:	<input type="checkbox"/>	Sample ID #

Frangible:	Bonded:	<input checked="" type="checkbox"/>	Not Detected:	<input type="checkbox"/>	References / Attachments / Comments:						
Condition:	Fair	Upright pipe attached to north west wall of cottage									
Photo Caption:	A/C stand pipe			Laboratory:	Envirolab Services Pty Ltd

Cert. of Analysis:	110214		Lead in Paint				
				Lab. Refer:	110214-4		%w/w				
				Enviroics Refer:	A004		Area m2:				
				Asbestos Detected - Yes:	<input checked="" type="checkbox"/>	No:	<input type="checkbox"/>	Asbestos			
				If Detected, What Type:	Chrysotile						
				Sample Description:	Area m2:		4				
				Grey compressed fibre cement material							
Asbestos Assessor:				Lawrie Lyons (Enviroics)			Drawings & Illustrations

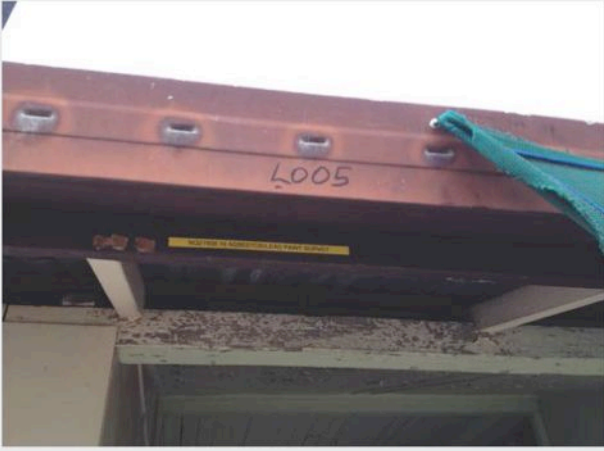
1.2. AHIR 140414-19 Facia Boards

Secondary Location:	North West	Quantity (m2):		Occupancy In Use:	<input type="checkbox"/> No In Use: <input checked="" type="checkbox"/>	Accessibility - Accessible:	<input checked="" type="checkbox"/> Inaccessible: <input type="checkbox"/>
Application:	Facia Board	Control - Encapsulate:	<input type="checkbox"/>	Leave and Manage:	<input type="checkbox"/>	Remove:	<input checked="" type="checkbox"/> N/A: <input type="checkbox"/> Other: <input type="text"/>
ACM Status:	Detected: <input type="checkbox"/>	Labels -	Appixed: <input checked="" type="checkbox"/>	Remove:	<input type="checkbox"/>	Required:	<input type="checkbox"/> Sample ID #:
Condition:	Fair	References / Attachments / Comments:					
Facia below gutter painted brown

Photo Caption:	L005 Sample Location	Laboratory:	EnviroLab Services Pty Ltd
----------------	----------------------	-------------	----------------------------

Cert. of Analysis:	110213	Lead in Paint
Lab. Refer:	110213-5	%w/w
EnviroLab Refer:	L005	Area m2:
		<0.05
		6

AHIR	ACM:	Estate Details:	Townsville Field Training Area, Fanning River Station.	ACM MGT:	Remove for demolition
-------------	------	-----------------	--	----------	-----------------------

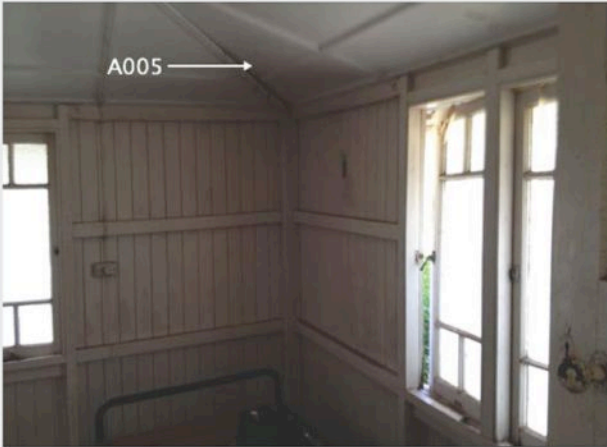
1.3. AHIR 140414-20 Ceiling of North East Bedroom

References / Attachments / Comments:					
Facia below gutter painted brown					
Photo Caption:	A005 Sample Location		Laboratory: Envirolab Services Pty Ltd

Cert. of Analysis: 110214 Lab. Refer: 110214-5 Envirionics Refer: A005		
			Lead in Paint %w/w <input type="text"/> Area m2: <input type="text"/>		
			Asbestos Detected - Yes: <input checked="" type="checkbox"/> No: <input type="checkbox"/> Asbestos If Detected, What Type: Chrysotile & Amosite Sample Description: Area m2: 13 Grey fibre cement material		
Asbestos Assessor: Lawrie Lyons (Envirionics)			Drawings & Illustrations

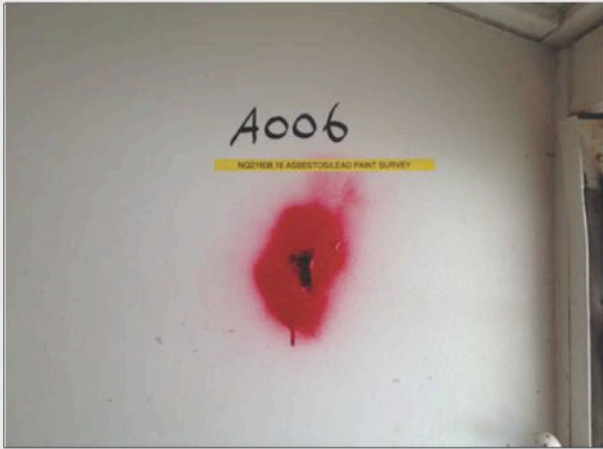
1.4. AHIR 140414-21 Bathroom Walls

Region:	NQ - NQ	Property:	TFTA (0233) CF3 P2 Fanning River Integration		Structure:	Cottage 1	
AHIR:	140414-21	Level:	Survey	Location:	GR 25.883 43.850	Space:	Internal Area
AHIR	ACM:	Chrysotile	Estate Details:	Townsville Field Training Area, Fanning River Station.		ACM MGT:	Remove for demolition
Secondary Location:	Bathroom	Quantity (m2):	18	Occupancy In Use:	<input type="checkbox"/>	No In Use:	<input checked="" type="checkbox"/>
Application:	Walls	Control - Encapsulate:	<input type="checkbox"/>	Leave and Manage:	<input type="checkbox"/>	Remove:	<input checked="" type="checkbox"/>
ACM Status:	Detected:	<input checked="" type="checkbox"/>	Labels -	Appixed:	<input checked="" type="checkbox"/>	Remove:	<input type="checkbox"/>
Friable:	<input type="checkbox"/>	Bonded:	<input checked="" type="checkbox"/>	Not Detected:	<input type="checkbox"/>	Required:	<input type="checkbox"/>
Condition:	Fair	Sample ID #: A006

References / Attachments / Comments:							
Walls							
Photo Caption:	A006 Sample Location			Laboratory:	Envirolab Services Pty Ltd

Cert. of Analysis:	110214		
				Lab. Refer:	110214-6		
				Enviroics Refer:	A006		
				Lead in Paint			
				%w/w	<input type="text"/>		
				Area m2:	<input type="text"/>		
Asbestos Detected - Yes: <input checked="" type="checkbox"/> No: <input type="checkbox"/> Asbestos							
If Detected, What Type: Chrysotile							
Sample Description: Area m2: 18							
Grey fibre cement material							
Asbestos Assessor: Lawrie Lyons (Enviroics)							
Drawings & Illustrations							
<p>Cottage 1</p> <p>Application to RED engine ti</p>

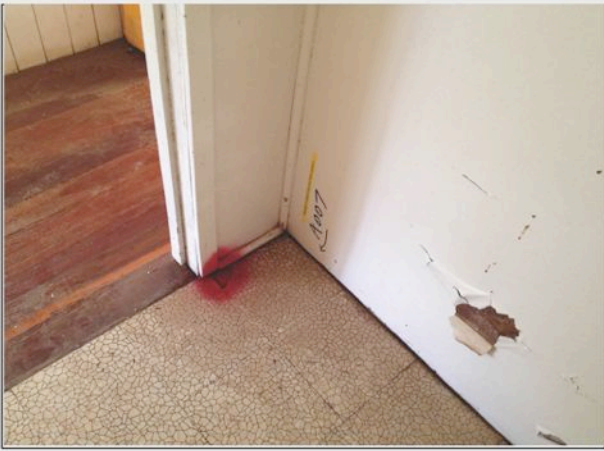
1.5. AHIR 140414-22 Bathroom Floor

Region:	NQ - NQ	Property:	TFTA (0233) CF3 P2 Fanning River Integration		Structure:	Cottage 1	
AHIR:	140414-22	Level:	Survey	Location:	GR 25.883 43.850	Space:	Internal Area
AHIR	ACM:	Chrysotile	Estate Details:	Townsville Field Training Area, Fanning River Station.		ACM MGT:	Remove for demolition
Secondary Location:	Bathroom	Quantity (m2):	3.6	Occupancy In Use:	<input type="checkbox"/>	No In Use:	<input checked="" type="checkbox"/>
Application:	Floors	Control - Encapsulate:	<input type="checkbox"/>	Leave and Manage:	<input type="checkbox"/>	Remove:	<input checked="" type="checkbox"/>
ACM Status:	Detected:	<input checked="" type="checkbox"/>	Labels -	Appixed:	<input checked="" type="checkbox"/>	Remove:	<input type="checkbox"/>
Friable:	<input type="checkbox"/>	Bonded:	<input checked="" type="checkbox"/>	Not Detected:	<input type="checkbox"/>	Required:	<input type="checkbox"/>
Condition:	Fair	Sample ID #: A007

References / Attachments / Comments:							
Vinyl tile if unable to be manual lifted and requires grinding will become friable.							
Photo Caption:	A007 Sample Location			Laboratory:	Envirolab Services Pty Ltd

Cert. of Analysis:	110214		
				Lab. Refer:	110214-7		
				Enviroics Refer:	A007		
				Lead in Paint %w/w <input type="text"/> Area m2: <input type="text"/>			
Asbestos Detected - Yes: <input checked="" type="checkbox"/> No: <input type="checkbox"/>				Asbestos			
If Detected, What Type:				Chrysotile			
Sample Description:				Area m2:		3.6	
Beige brittle vinyl tile							
Asbestos Assessor:				Lawrie Lyons (Enviroics)			
Drawings & Illustrations

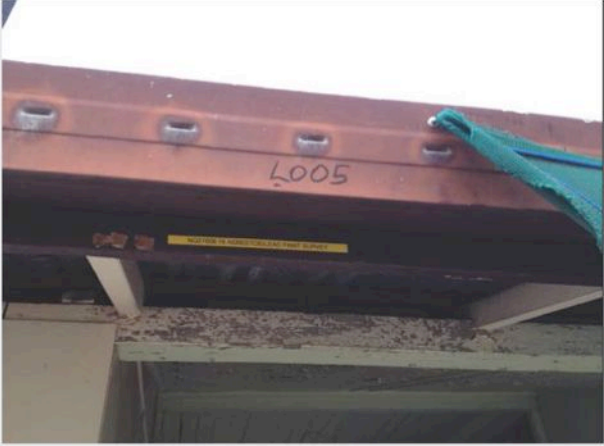
1.1. AHIR 140414-19 Facia Boards

Region:	NQ - NQ	Property:	TFTA (0233) CF3 P2 Fanning River Integration		Structure:	Cottage 1	
AHIR:	140414-19	Level:	Survey	Location:	GR 25.883 43.850	Space:	External Area
ACM:			Estate Details:	Townsville Field Training Area, Fanning River Station.		ACM MGT:	Remove for demolition
Secondary Location:	North West		Quantity (m2):			Occupancy In Use:	<input type="checkbox"/> No In Use: <input checked="" type="checkbox"/>
Application:	Facia Board		Control - Encapsulate:	<input type="checkbox"/>		Leave and Manage:	<input type="checkbox"/>
ACM Status:	Detected: <input type="checkbox"/>		Labels - Applied:	<input checked="" type="checkbox"/>		Remove:	<input type="checkbox"/>
Condition:	Fair		References / Attachments / Comments:	Facia below gutter painted brown			
Photo Caption:	L005 Sample Location		Laboratory:	Envirolab Services Pty Ltd

Cert. of Analysis:	110213		Lead in Paint %w/w: <0.05 Area m2: 6

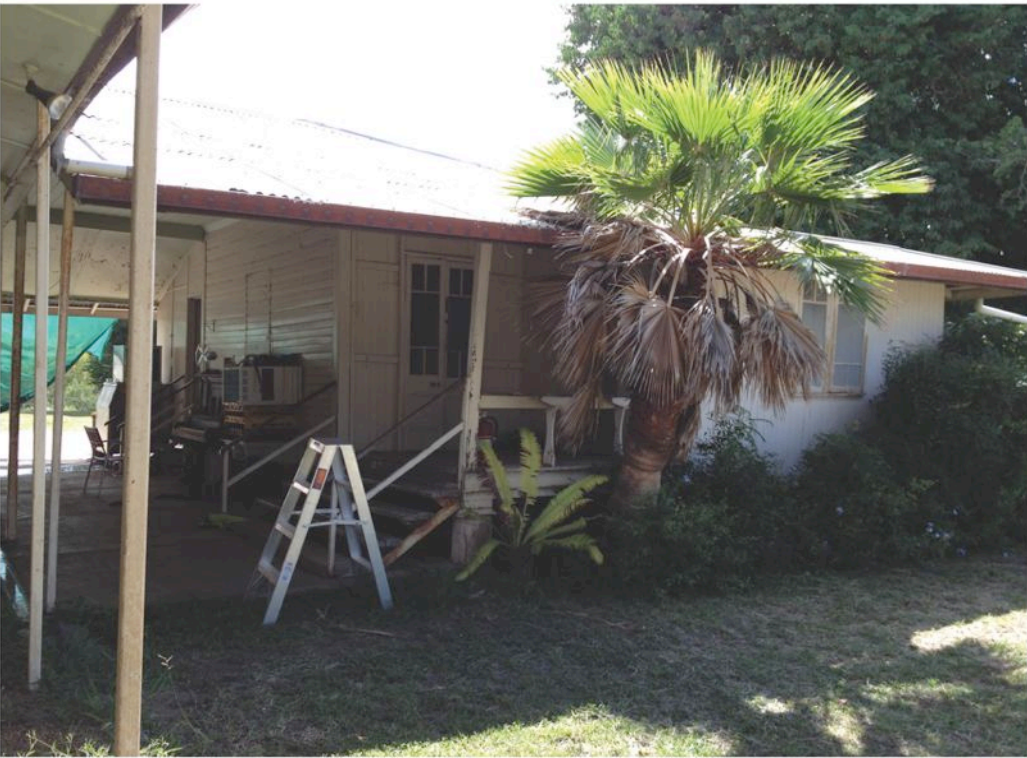
1.2. AHIR 140414-19B Ext. & Internal Walls, & Ceilings

Secondary Location:	Walls & Ceilings	Quantity (m2):		Occupancy In Use:	<input type="checkbox"/>	No In Use:	<input checked="" type="checkbox"/>	Accessibility - Accessible:	<input type="checkbox"/>	Inaccessible:	<input type="checkbox"/>
Application:		Control - Encapsulate:	<input type="checkbox"/>	Leave and Manage:	<input type="checkbox"/>	Remove:	<input checked="" type="checkbox"/>	N/A:	<input type="checkbox"/>	Other:	
ACM Status:	Detected:	<input type="checkbox"/>									
	Friable:	<input type="checkbox"/>	Bonded:	<input type="checkbox"/>	Not Detected:	<input type="checkbox"/>					
Condition:	Fair

<div style="height: 150px; border: 1px solid black;"></div>	<table border="1" style="width:100%; border-collapse: collapse;"> <tr> <td style="width:60%;">Cert. of Analysis:</td> <td>110213</td> </tr> <tr> <td>Lab. Refer:</td> <td>110213-3</td> </tr> <tr> <td>Envionics Refer:</td> <td>L003</td> </tr> </table> <table border="1" style="width:100%; border-collapse: collapse;"> <tr> <th colspan="2">Lead in Paint</th> </tr> <tr> <td>%w/w</td> <td>0.2</td> </tr> <tr> <td>Area m2:</td> <td>250</td> </tr> </table> <table border="1" style="width:100%; border-collapse: collapse;"> <tr> <td>Asbestos Detected - Yes:</td> <td><input type="checkbox"/></td> <td>No:</td> <td><input type="checkbox"/></td> <td>Asbestos</td> </tr> <tr> <td>If Detected, What Type:</td> <td colspan="4"></td> </tr> <tr> <td>Sample Description:</td> <td>Area m2:</td> <td colspan="3"></td> </tr> <tr> <td colspan="5" style="height: 30px;"></td> </tr> </table>	Cert. of Analysis:	110213	Lab. Refer:	110213-3	Envionics Refer:	L003	Lead in Paint		%w/w	0.2	Area m2:	250	Asbestos Detected - Yes:	<input type="checkbox"/>	No:	<input type="checkbox"/>	Asbestos	If Detected, What Type:					Sample Description:	Area m2:

AHIR	ACM:	Estate Details:	Townsville Field Training Area, Fanning River Station.	ACM MGT:	Remove for demolition
------	------	-----------------	---	----------	-----------------------
