# Asbestos Assessor's Report:

TFTA (0233) CF3 P2  
Fanning River Integration – WORKSHOP

Environics, 12<sup>th</sup> June 2014 – Environics-rpt-140612-3-rev0

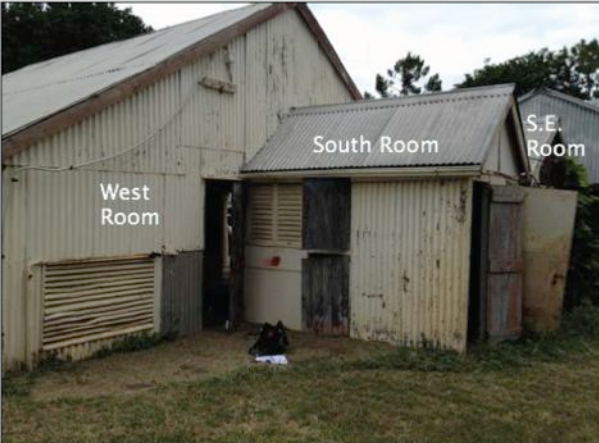
### 1.1. AHIR 140414-25 Walls of S.W. Room

| ACM: | Chrysotile | Estate Details: | Townsville Field Training Area, Fanning River Station. | | ACM MGT: | Remove for demolition | | | | | |
| Secondary Location: | S.E. Room | Quantity (m2): | 28 | Occupancy In Use: | <input type="checkbox"/> | No In Use: | <input checked="" type="checkbox"/> | Accessibility - Accessible: | <input checked="" type="checkbox"/> | Inaccessible: | <input type="checkbox"/> |
| Application: | Walls | Control - Encapsulate: | <input type="checkbox"/> | Leave and Manage: | <input type="checkbox"/> | Remove: | <input checked="" type="checkbox"/> | N/A: | <input type="checkbox"/> | Other: | |
| Condition: | Poor | South East Room of Workshop | | | | | | | | | |
| Photo Caption: | A007 Sample Location | | Laboratory: | | Envirolab Services Pty Ltd | | | | | | |
| If Detected, What Type: | | | Chrysotile | | | | | | | | |

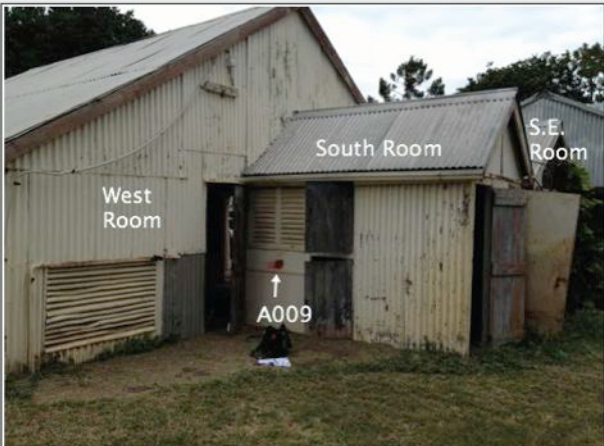
## 1.2. AHIR 140414-26 West Walls of South Room

| Condition: | Poor | Sample ID #: | A009 | | |
| Photo Caption: A009 Sample Location | | | | | |

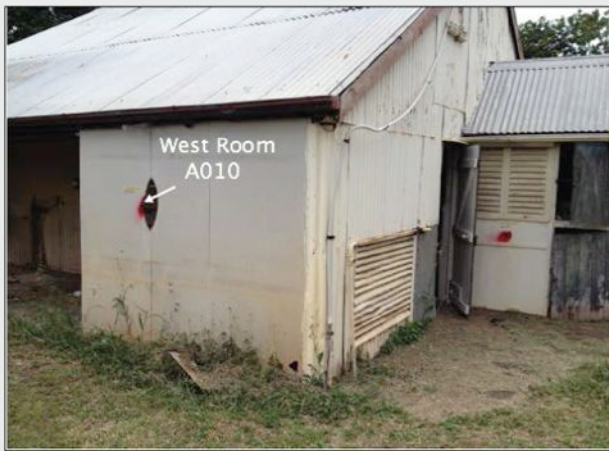
### 1.3. AHIR 140414-27 Wall of West Room

| Condition: Poor | | | | | | | | |

| Photo Caption: | A007 Sample Location | Laboratory: | EnviroLab Services Pty Ltd |

West Room A010

| Grey compressed fibre cement material | | |

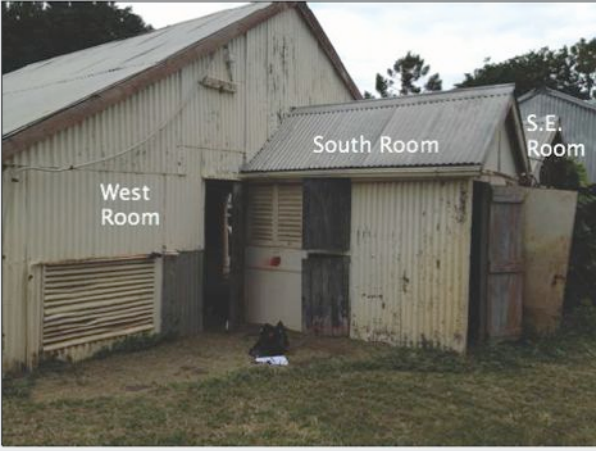
## 1.4. AHIR 140414-28 Internal Walls of Main Room

| <b>AHIR</b><br>Secondary Location: <b>Main Room</b><br>Application: <b>Walls</b><br>ACM Status: <input type="checkbox"/> Detected <input type="checkbox"/> Friable <input type="checkbox"/> Bonded <input type="checkbox"/> Not Detected <input type="checkbox"/> Condition: <b>Poor</b> | <b>ACM:</b> Non Asbestos<br><b>Quantity (m2):</b> <input type="text"/><br><b>Control -</b> Encapsulate: <input type="checkbox"/> Leave and Manage: <input type="checkbox"/> Remove: <input checked="" type="checkbox"/> N/A: <input type="checkbox"/> Other: <input type="text"/><br><b>Labels -</b> Applied: <input checked="" type="checkbox"/> Remove: <input type="checkbox"/> Required: <input type="checkbox"/> Sample ID #: <input type="text"/><br><b>References / Attachments / Comments:</b><br>Walls of the main room are Masonite. | <b>Estate Details:</b> Townsville Field Training Area, Fanning River Station.<br><b>ACM MGT:</b> Remove for demolition |

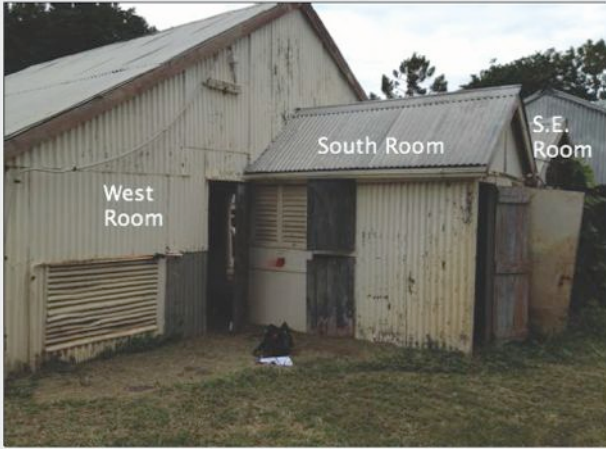
## 1.5. AHIR 140414-29A Ceilings of Main Room

| | | | | Ceilings of Main Room are Masonite | | | |

| Grey compressed fibre cement material | |

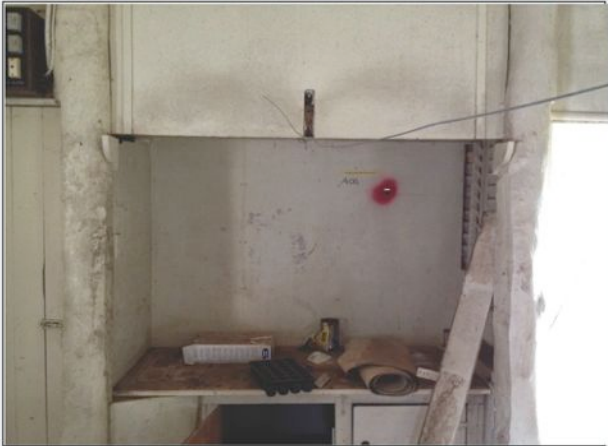
## 1.6. AHIR 140414-30 Wall Panel, Work Bench, Main Room

| Condition: | Poor | On the south side of the main room is a work bench and above the bench is a panel of A/C sheet. | | | | | | | | | |

| Photo Caption: | A011 Sample Location | Laboratory: | Envirolab Services Pty Ltd |

| Grey compressed fibre cement material | | | | |

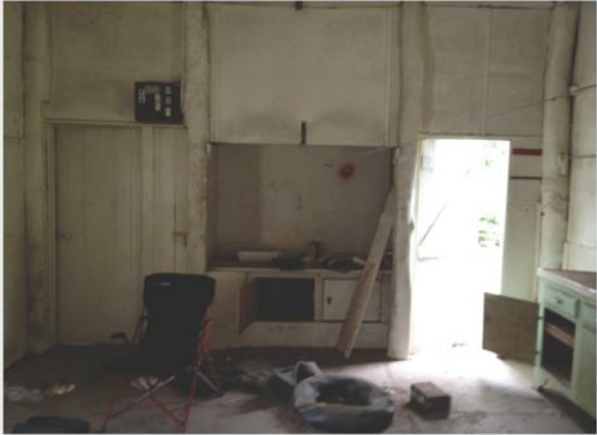
The off-white paint of the workshop is of the same type as House 1 and contains a very low concentration of lead i.e. %w/w less than 0.05.

| Condition: | Poor | Ceilings of Main Room are Masonite - the cream paint is the same as house 1 that was found to contain lead in very low concentration. | | | | | | | | | |
| | | | | Lab. Refer: | 110213-2 | | | %w/w | < 0.05 | | |
