Reference: NO21608.16

# **Asbestos Assessor's Report:**

## **TFTA (0233) CF3 P2**

### **Fanning River Integration – HOUSE TWO**

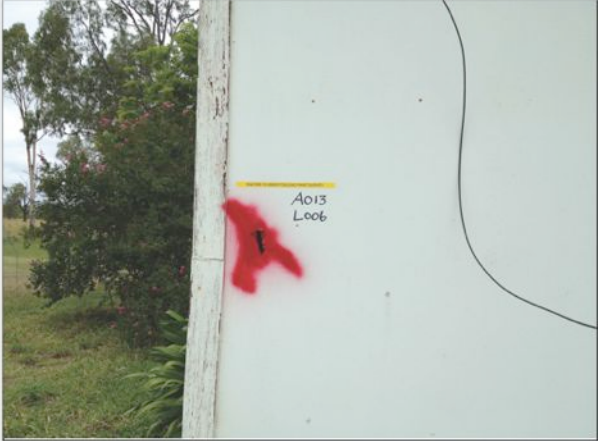
| Condition: | Poor | | Sample taken from north east wall | | | | | | | | | |
| If Detected, What Type: | | | | Chrysotile | | | | | | | | |
| Grey compressed fibre cement material | | | | | | | | | | | | |

| Application: | Lining | | Control - Encapsulate: | <input type="checkbox"/> | Leave and Manage: | <input type="checkbox"/> | Remove: | <input checked="" type="checkbox"/> | N/A: | <input type="checkbox"/> | Other: | |

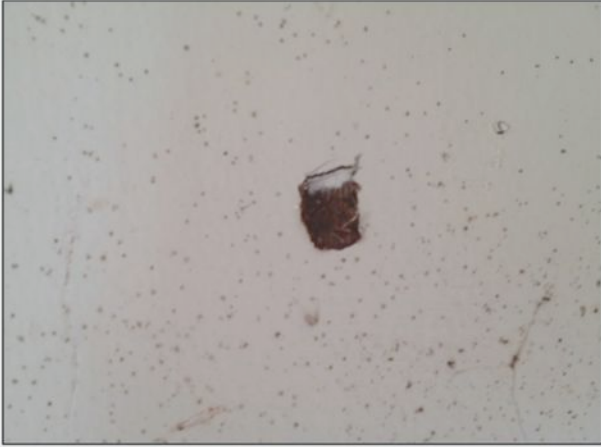
| Internal walls and ceilings found to be Masonite, floors under vinyl found to be timber | | | | | | | |

| Photo Caption: | Masonite painted off white | Laboratory: | Not required |

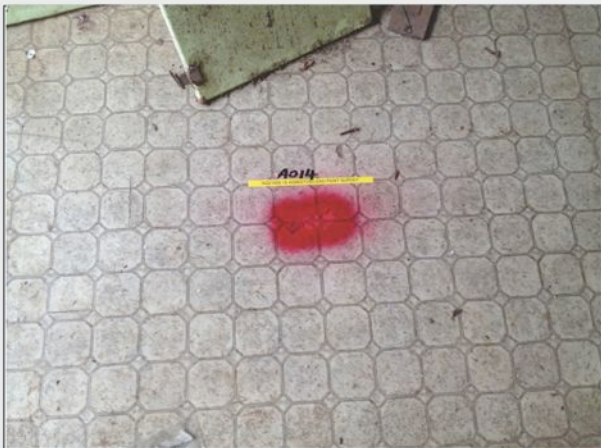
| Photo Caption: Sample location, Kitchen | Laboratory: Envirolab Services Pty Ltd |

| Grey vinyl flooring with millboard backing material. | | | | | | | | | | | |

| Millboard backed beige vinyl sheet | | | | |

Many of the ACMs may be removed under B-Class controls as the risk is low to medium. However, the millboard backing of the kitchen vinyl will require an A-class removal.

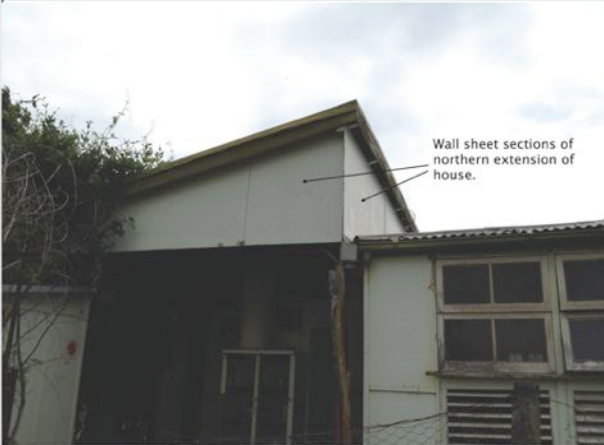
| <b>References / Attachments / Comments:</b><br>Section running south west to north east above the roof of the main section of the house where an extension has been made to the north. | | | | | | | |
| <p>Wall sheet sections of northern extension of house.</p> | | | | Cert. of Analysis: | | 110214 | <b>Lead in Paint</b><br>%w/w <input type="text"/><br>Area m2: <input type="text"/> |
| | | | | Grey compressed fibre cement material | | | |

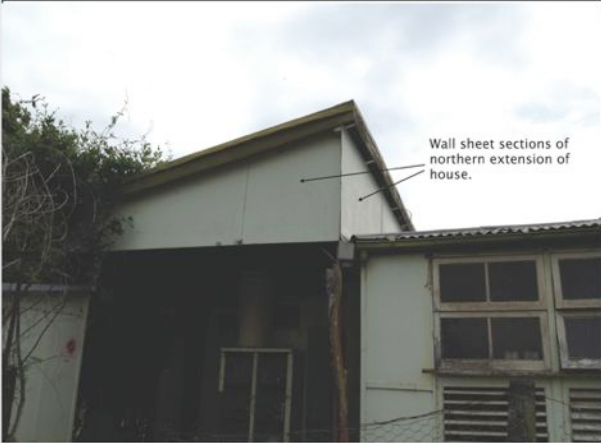
| Condition: | Poor | | Section running south west to north east above the roof of the main section of the house where an extension has been made to the north. | | | | | | |
| | | | Grey compressed fibre cement material | | | | | | |
