# **Asbestos Assessor's Report:**

## **TFTA (0233) CF3 P2**

### **Fanning River Integration – HOUSE THREE**

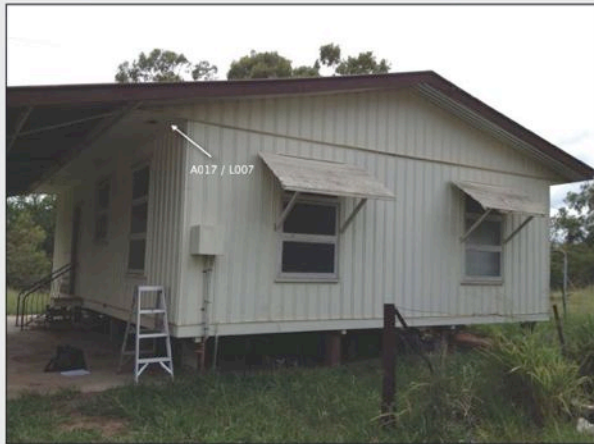
Photo Caption: A017 Sample Location

Friable:	<input type="checkbox"/> Bonded:	<input checked="" type="checkbox"/>	Not Detected:	<input type="checkbox"/>	References / Attachments / Comments:				
Condition:	Poor	Sample taken from south east eave of house.

If Detected, What Type: Chrysotile & Amosite

Grey compressed fibre cement material

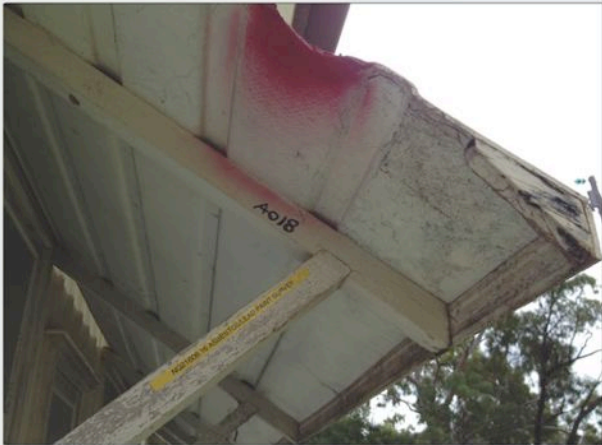
Photo Caption:	A018 Sample Location	Laboratory:	EnviroLab Services Pty Ltd
----------------	----------------------	-------------	----------------------------

ACM:	Chrysotile & Amosite	Estate Details:	Townsville Field Training Area, Fanning River Station.	ACM MGT:	Remove for demolition
Secondary Location:	Awning	Quantity (m2):	14	Occupancy In Use:	<input type="checkbox"/> No In Use: <input checked="" type="checkbox"/>
Application:	Shade	Control - Encapsulate:	<input type="checkbox"/> Leave and Manage: <input type="checkbox"/> Remove: <input checked="" type="checkbox"/>	N/A:	<input type="checkbox"/> Other: <input type="checkbox"/>
ACM Status:	Detected: <input checked="" type="checkbox"/> Friable: <input type="checkbox"/> Bonded: <input checked="" type="checkbox"/> Not Detected: <input type="checkbox"/>	Labels - Appixed:	<input checked="" type="checkbox"/> Remove: <input type="checkbox"/> Required: <input type="checkbox"/>	Sample ID #:	A018
References / Attachments / Comments:					
Sample taken from awning on the northern side of the house.

Asbestos Detected - Yes:	<input checked="" type="checkbox"/> No: <input type="checkbox"/>	<b>Asbestos</b>
If Detected, What Type:	Chrysotile & Amosite	
Sample Description:	Area m2:	14
Grey compressed fibre cement material

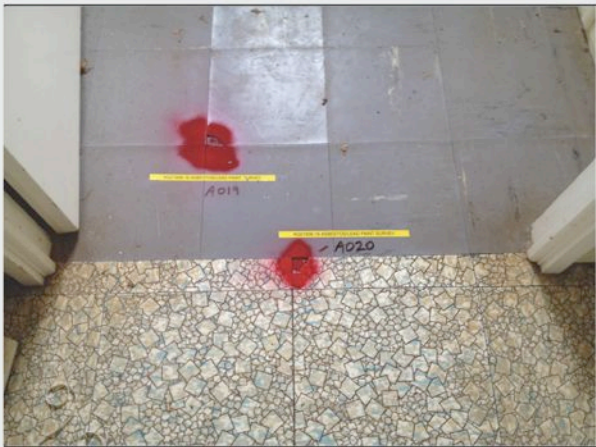
Condition:	Poor		Grey brittle vinyl tile contains asbestos however the underlying adhesive contains no asbestos (refer to laboratory results for more details).					
Photo Caption:	A019 Sample Location		Laboratory:				Envirolab Services Pty Ltd

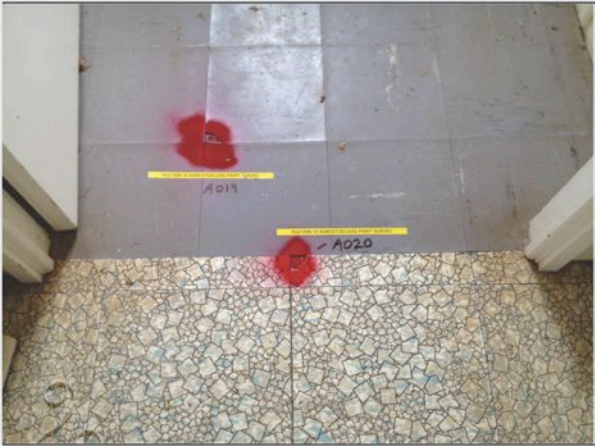
Photo Caption:	A020 Sample Location	Laboratory:	EnviroLab Services Pty Ltd
----------------	----------------------	-------------	----------------------------

Secondary Location:	Vinyl tile & adhesive	Quantity (m2):	6	Occupancy In Use:	<input type="checkbox"/>	No In Use:	<input checked="" type="checkbox"/>	Accessibility - Accessible:	<input checked="" type="checkbox"/>	Inaccessible:	<input type="checkbox"/>
Application:	Kitchen flooring	Control - Encapsulate:	<input type="checkbox"/>	Leave and Manage:	<input type="checkbox"/>	Remove:	<input checked="" type="checkbox"/>	N/A:	<input type="checkbox"/>	Other:	
ACM Status:	Detected: <input checked="" type="checkbox"/>	Labels -	Appixed: <input checked="" type="checkbox"/>	Remove:	<input type="checkbox"/>	Required:	<input type="checkbox"/>	Sample ID #:	A020		
Friable:	<input type="checkbox"/>	Bonded:	<input checked="" type="checkbox"/>	Not Detected:	<input type="checkbox"/>	References / Attachments / Comments:					
Condition:	Marble coloured vinyl contains asbestos however the underlying adhesive contains no asbestos (refer to laboratory results for more details).

Asbestos Detected - Yes:	<input checked="" type="checkbox"/>	No:	<input type="checkbox"/>	<b>Asbestos</b>
If Detected, What Type:	Chrysotile			
Sample Description:	Area m2: 6			
Marble colored vinyl

Many of the ACMs may be removed under B-Class controls as the risk is low to medium. However, the millboard backing of the kitchen vinyl will require an A-class removal.

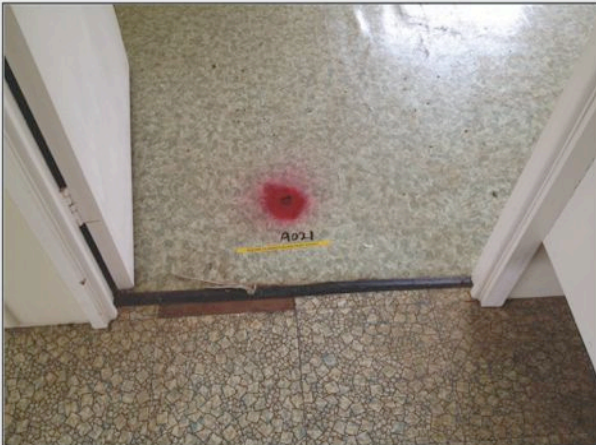
Photo Caption:	A021 Sample Location	Laboratory:	EnviroLab Services Pty Ltd

ACM:	Estate Details: Townsville Field Training Area, Fanning River Station.		ACM MGT:	Remove for demolition	
Secondary Location:	Fibrous Vinyl	Quantity (m2):	18	Occupancy In Use:	<input type="checkbox"/> No In Use: <input checked="" type="checkbox"/>
Application:	Bedroom flooring	Control - Encapsulate:	<input type="checkbox"/> Leave and Manage:	<input type="checkbox"/> Remove:	<input checked="" type="checkbox"/> N/A: <input type="checkbox"/> Other:
ACM Status:	Detected: <input type="checkbox"/> Friable: <input type="checkbox"/> Bonded: <input checked="" type="checkbox"/> Not Detected: <input checked="" type="checkbox"/>	Labels - Appixed:	<input checked="" type="checkbox"/> Remove:	<input type="checkbox"/> Required:	Sample ID #: A021
References / Attachments / Comments:					
Fibrous bituminous backed vinyl					
Condition:	Poor

Asbestos Detected - Yes:	<input type="checkbox"/> No:	<input checked="" type="checkbox"/> <b>Asbestos</b>
If Detected, What Type:		
Sample Description:	Area m2:	18
Fibrous bituminous backed vinyl

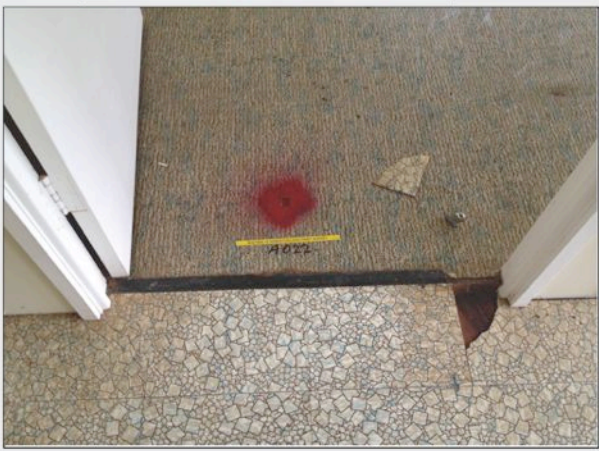
Condition:	Poor	References / Attachments / Comments:					
Fibrous bituminous backed vinyl							
Photo Caption:	A022 Sample Location			Laboratory:	Envirolab Services Pty Ltd

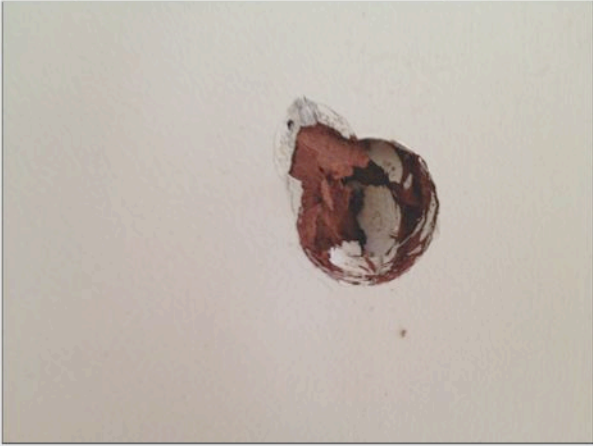
References / Attachments / Comments:			
Condition: Poor				Walls and ceilings of house found to be masonite.			
Photo Caption:		Sample Location		Laboratory:		Envirolab Services Pty Ltd

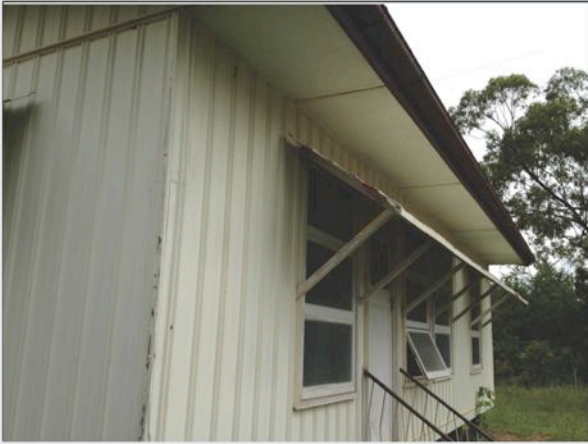
Condition:	Poor	References / Attachments / Comments: The house is extensively painted with the same green paint. A very low concentration of lead detected in the paint.						
Photo Caption:	L007 Sample location		Laboratory: Envirolab Services Pty Ltd

Cert. of Analysis:		110213		<b>Lead in Paint</b> %w/w < 0.05 Area m2: 14
				Lab. Refer:		110213-7		
				Enviroconics Refer:		L007		
				Asbestos Detected - Yes: <input type="checkbox"/> No: <input type="checkbox"/>		<b>Asbestos</b>		
				If Detected, What Type:				
				Sample Description:		Area m2:		14
				Not applicable				
Asbestos Assessor: Lawrie Lyons (Enviroconics)								
Drawings & Illustrations								
<p style="text-align: center;"><b>House 3</b></p> <p style="text-align: center;">Red = Asbestos      No Asbestos Detected</p>
