# **Asbestos Assessor's Report:**

TFTA (0233) CF3 P2

Fanning River Integration – COTTAGE TWO

Environics, 29<sup>th</sup> June 2014 – Environics-rpt-140612-6-rev0

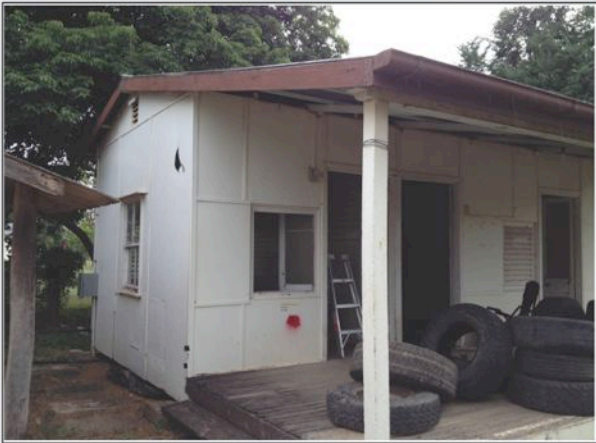
| AHIR | ACM: | A/C sheets | | Estate Details: | Townsville Field Training Area, Fanning River Station. | | ACM MGT: | Remove for demolition | | | | |
| Secondary Location: | External Wall | | Quantity (m2): | 56 | Occupancy In Use: | <input type="checkbox"/> | No In Use: | <input checked="" type="checkbox"/> | Accessibility - Accessible: | <input type="checkbox"/> | Inaccessible: | <input type="checkbox"/> |
| Condition: | Poor | | | | | | | | | | | |
| If Detected, What Type: | | | | Chrysotile & Amosite | | | | | | | | |
| Brown compressed fibre cement material | | | | | | | | | | | | |

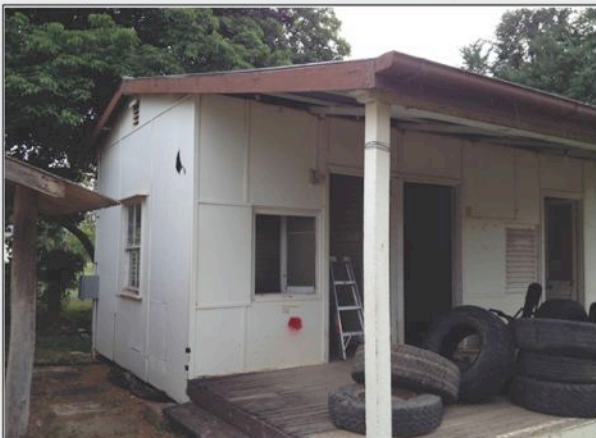
| AHIR | ACM: not applicable i.e. LEAD | | Estate Details: Townsville Field Training Area, Fanning River Station. | | ACM MGT: Remove for demolition | | | |
| Secondary Location: | External Wall | | Quantity (m2): | | Occupancy In Use: | <input type="checkbox"/> | No In Use: <input checked="" type="checkbox"/> | |
| Condition: | Poor | | References / Attachments / Comments: | | | | | |
| | | | Lab. Refer: | 110213-08 | | %w/w | 3.3 | |
| | | | Environics Refer: | L008 | | Area m2: | 56 | |

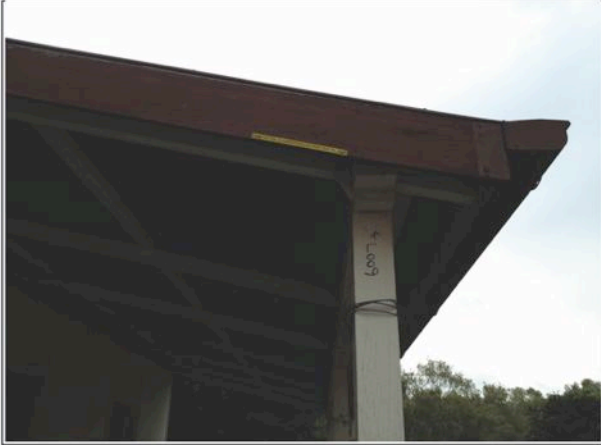
| Photo Caption: | L009 Sample Location | Laboratory: | EnviroLab Services Pty Ltd |

| Condition: | Poor | | | | | | | | | | |

| Lab. Refer: | 110213-09 | %w/w | <0.05 |
| EnviroLab Refer: | L009 | Area m2: | 15 |
