# **Asbestos Assessor's Report:**

## **TFTA (0233) CF3 P2**

### **Fanning River Integration – COTTAGE THREE**

Environics, 29<sup>th</sup> June 2014 – Environics-rpt-140612-7-rev0

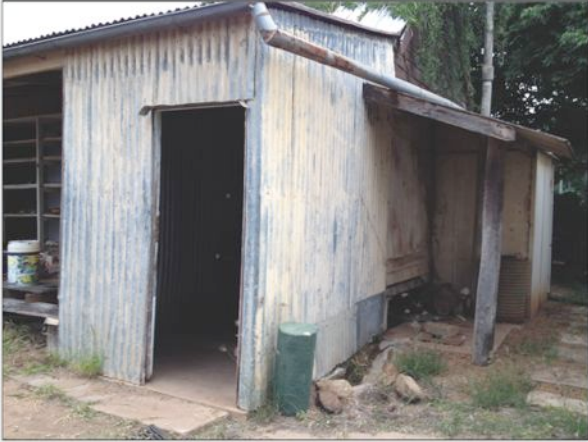
| Condition: | Poor | | Chrysotile asbestos detected in lining sheet north internal wall. | | | | | | | | | | | | |
| | | | | If Detected, What Type: | | | Chrysotile | | | Sample Description: | | | Area m2: > 2 | | |
| | | | | Grey compressed fibre cement material | | | | | | | | | | | |

| ACM: | A/C sheets | | Estate Details: | | Townsville Field Training Area, Fanning River Station. | | ACM MGT: | Remove for demolition | | | | | | | |
| Application: | Lining | | Control - Encapsulate: | <input type="checkbox"/> | Leave and Manage: | <input type="checkbox"/> | Remove: | <input checked="" type="checkbox"/> | N/A: | <input type="checkbox"/> | Other: | | | | |

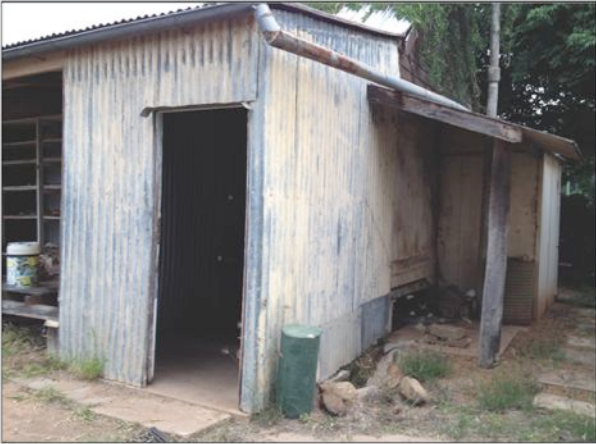
| Condition: | Poor | Chrysotile asbestos detected in lining sheet for shower against western internal wall. | | | | | | | | |
| | | | | If Detected, What Type: | | | | Chrysotile | | |
| | | | | Grey compressed fibre cement material | | | | | | |

| AHIR | ACM: | A/C sheets | | Estate Details: | Townsville Field Training Area, Fanning River Station. | | ACM MGT: | Remove for demolition | | |
| Application: | Lining | Control - Encapsulate: | <input type="checkbox"/> Leave and Manage: | <input type="checkbox"/> Remove: | <input checked="" type="checkbox"/> | N/A: | <input type="checkbox"/> Other: | | | |
