# Asbestos Assessor's Report:

TFTA (0233) CF3 P2  
Fanning River Integration – INFRASTRUCTURE

Environics, 29<sup>th</sup> June 2014 – Environics-rpt-140612-8-rev0

**RE:** NQ21608.16

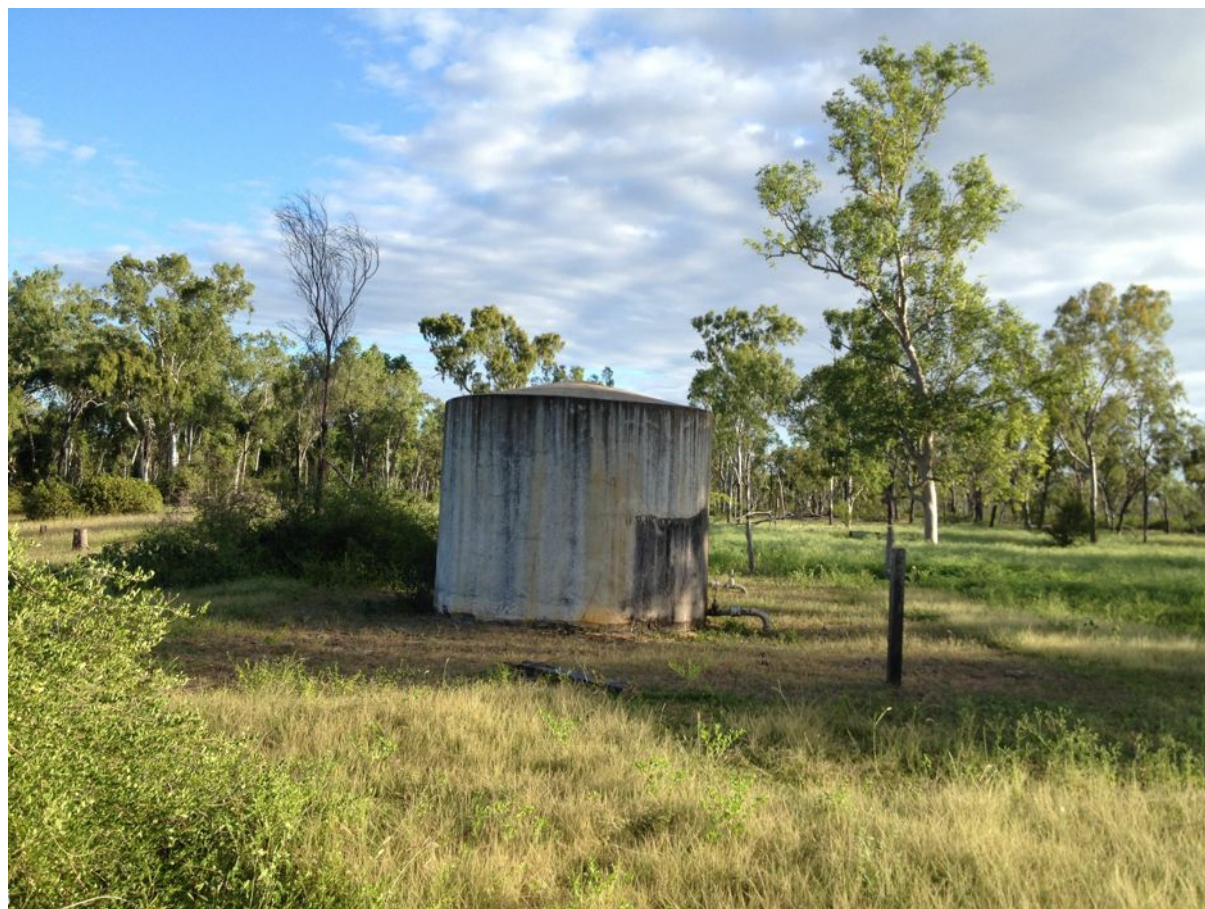
#### **Photograph 1 – Showing Typical Water Storage Tank**

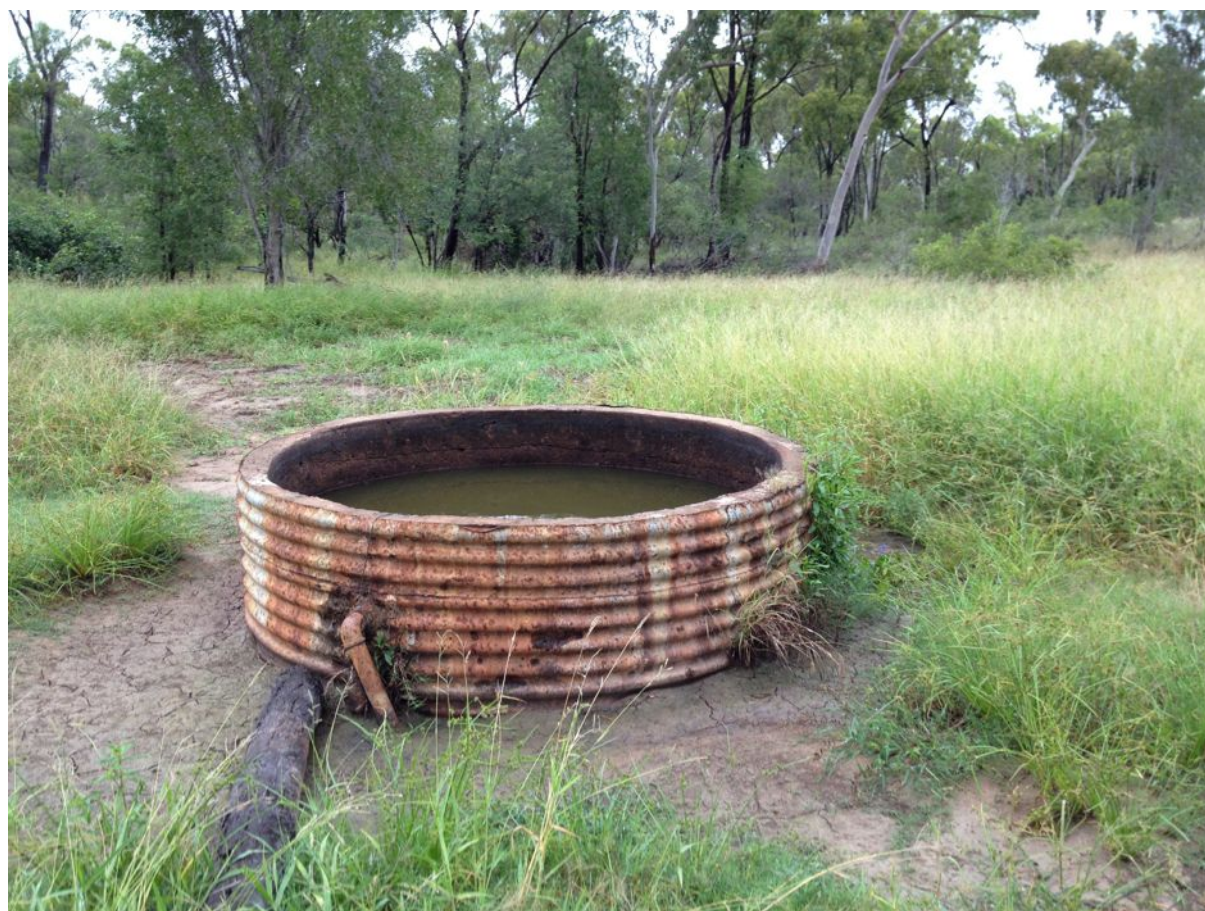
#### **AHIR 140414-54 Water Tank (Non-Asbestos)**

Description: Concrete and tin water tank

Sample 110214-28 (EnviroNics reference A028):

Grey quartz cement material - No asbestos detected

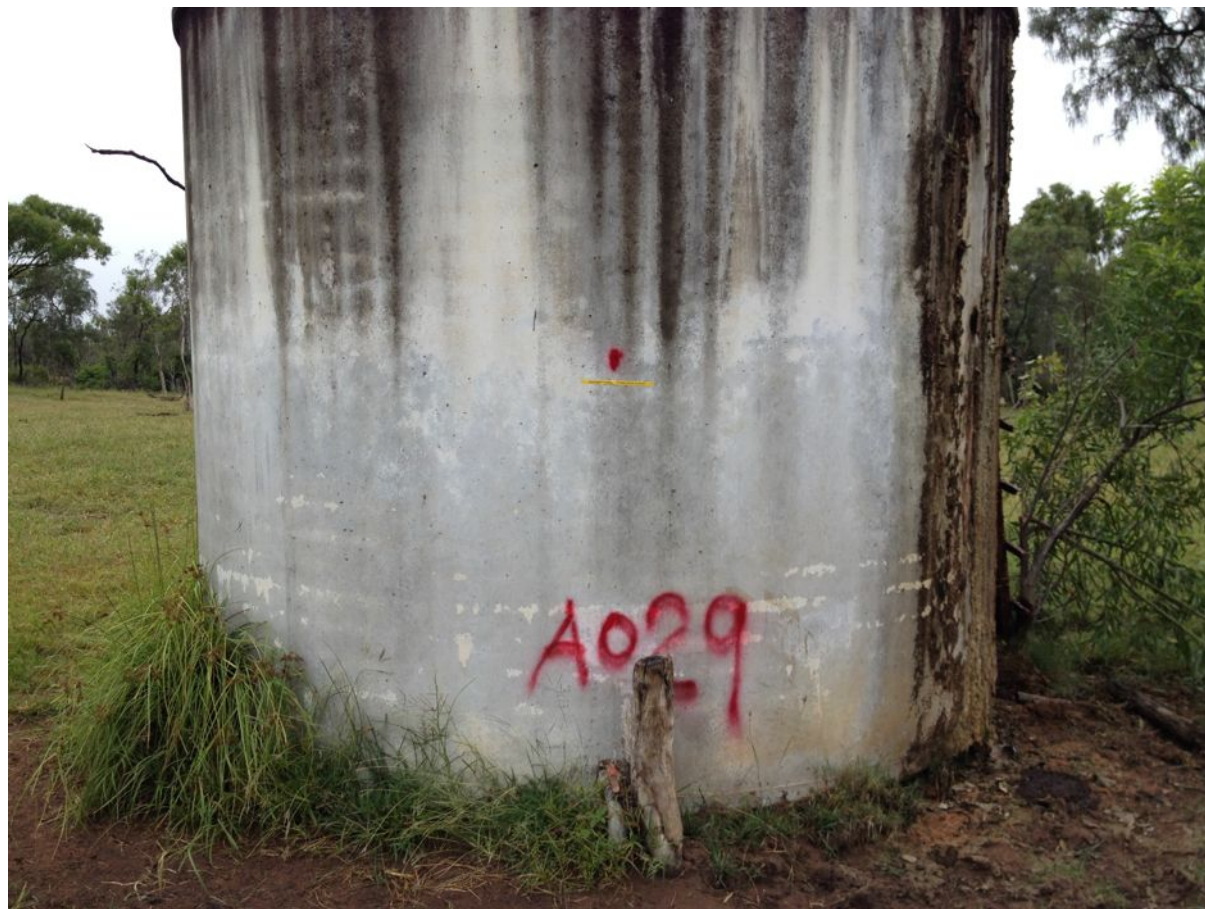
**AHIR 140414-55 Water Tank (Non-Asbestos)**

Description: Concrete and tin water tank

Sample 110214-29 (Environics reference A029):

Grey quartz cement material - No asbestos detected

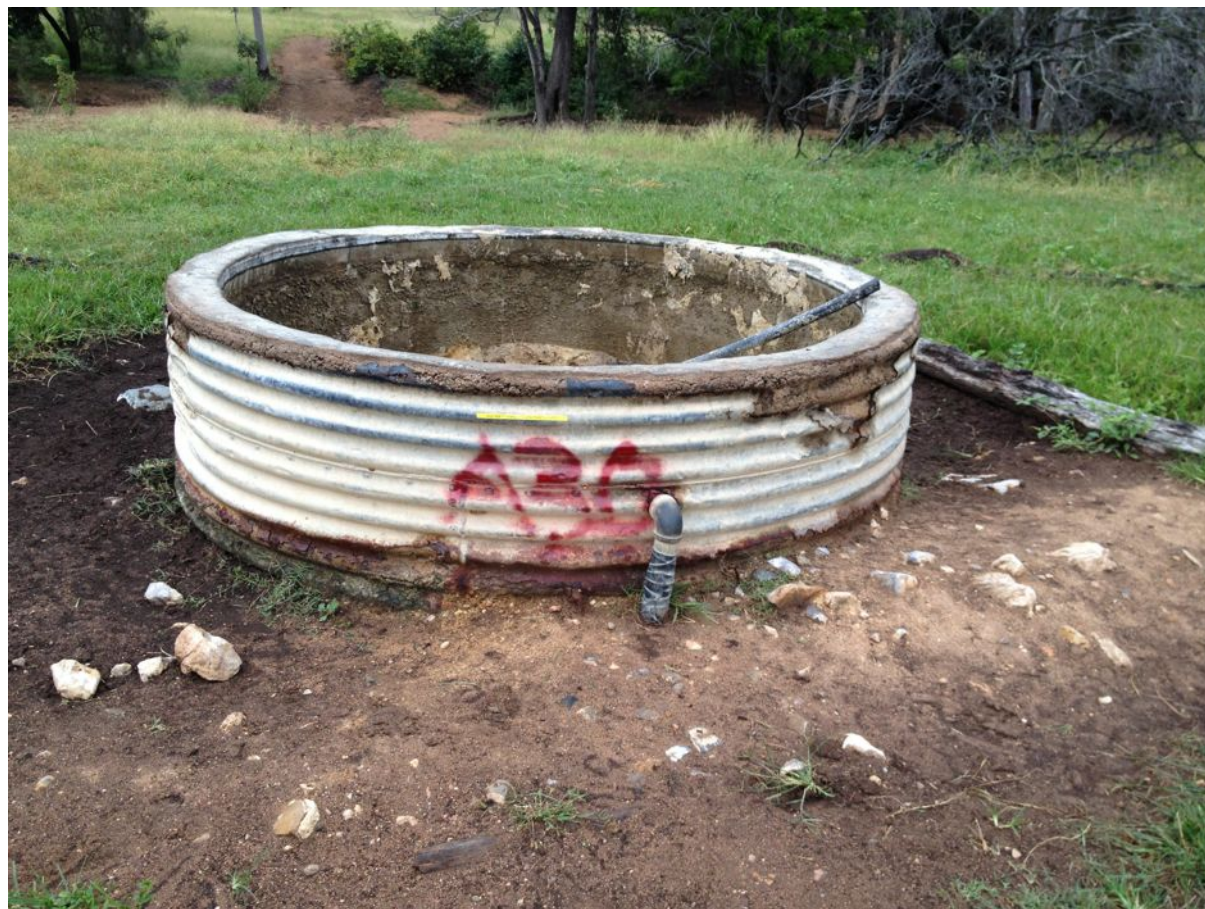
## **AHIR 140414-56 Water Tank (Non-Asbestos)**

Description: Concrete and tin water tank

Sample 110214-30 (EnviroNics reference A030):

Beige compressed pebbly cement material- No asbestos detected

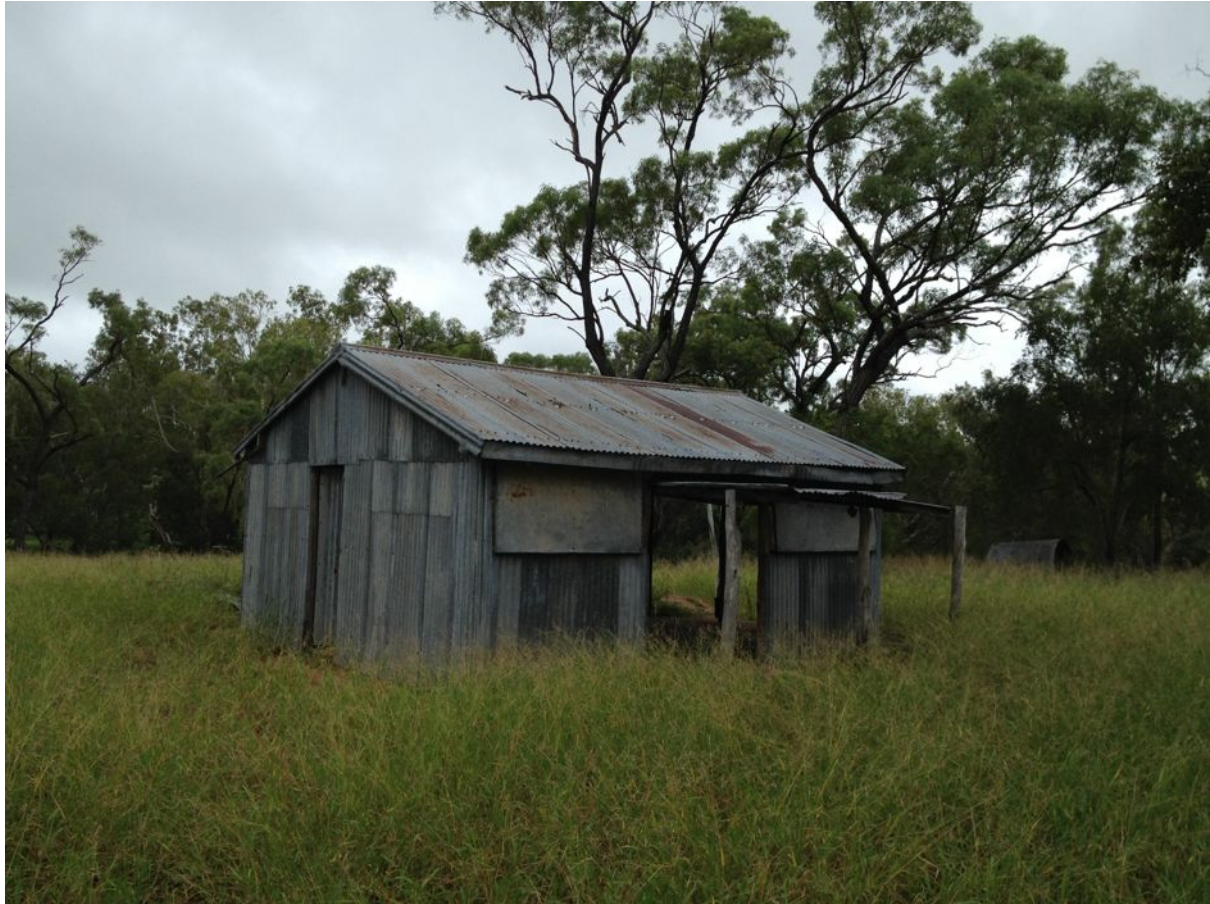
### **AHIR 140414-58 Concrete, Tin and Timber Shed**

Description: Tin and Bush Timber Shed

No evidence of asbestos containing materials.

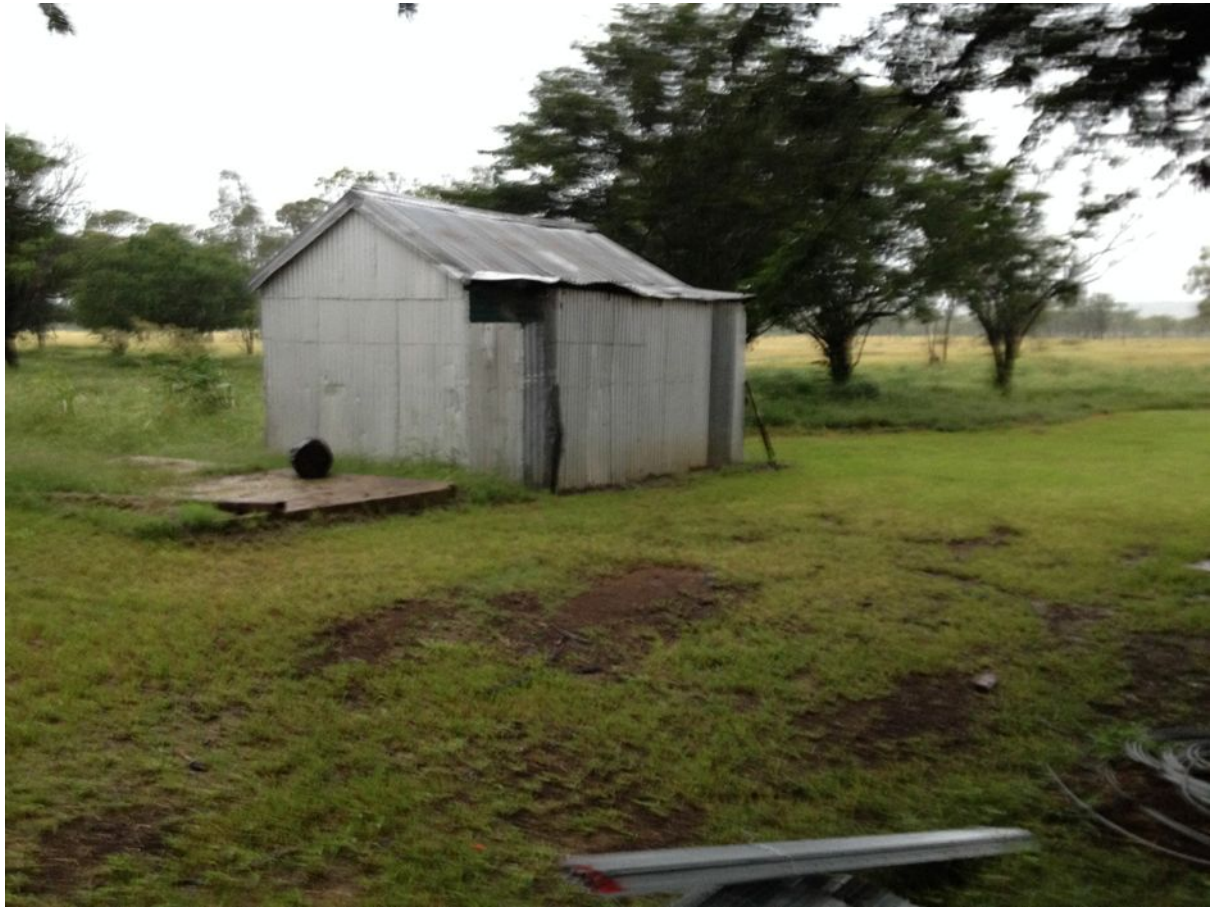
**AHIR 140414-59 Concrete, Tin and Timber Shed**

Description: Tin and Bush Timber Shed

No evidence of asbestos containing materials.

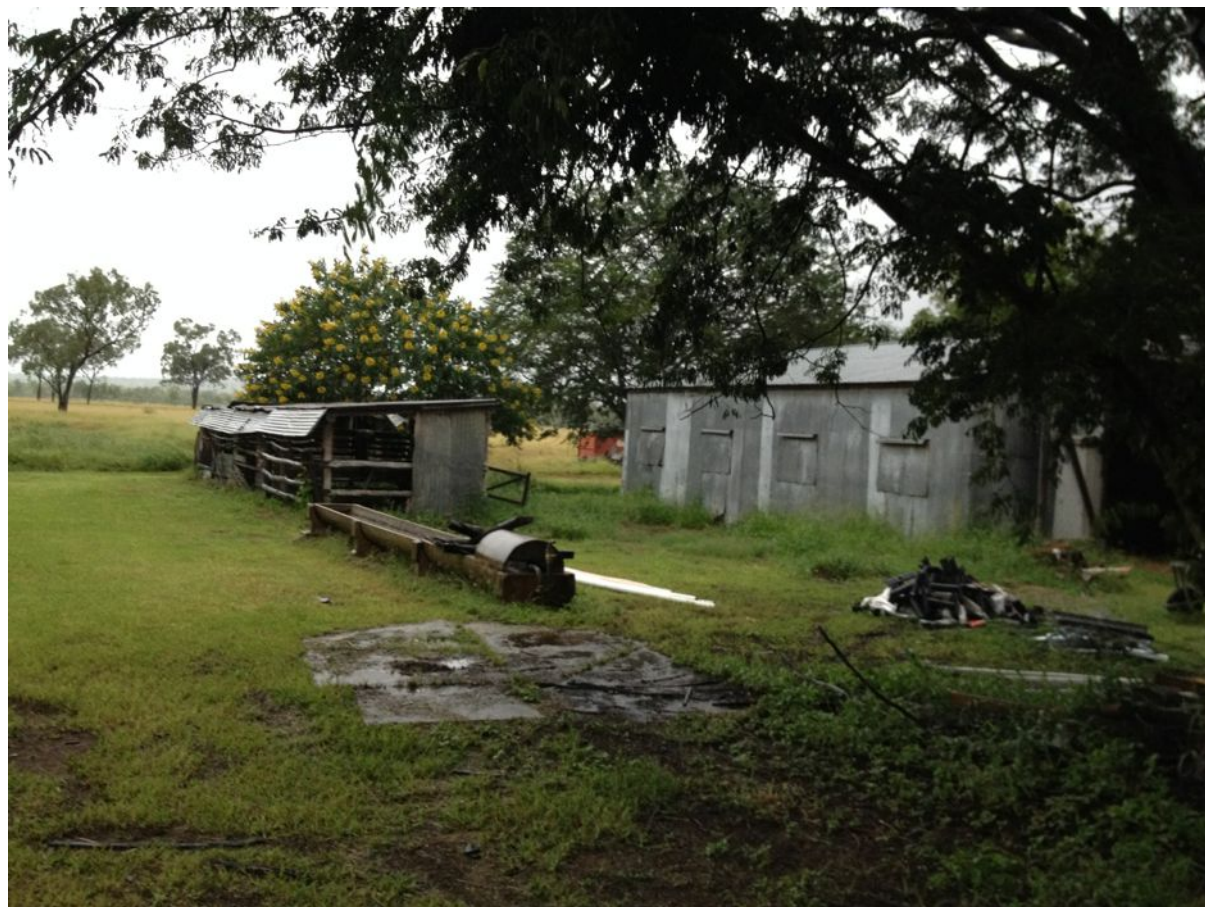
**AHIR 140414-60 Concrete, Tin & Timber Trough & Shelter**

Description: Tin and Bush Timber Trough and Shelter

No evidence of asbestos containing materials.

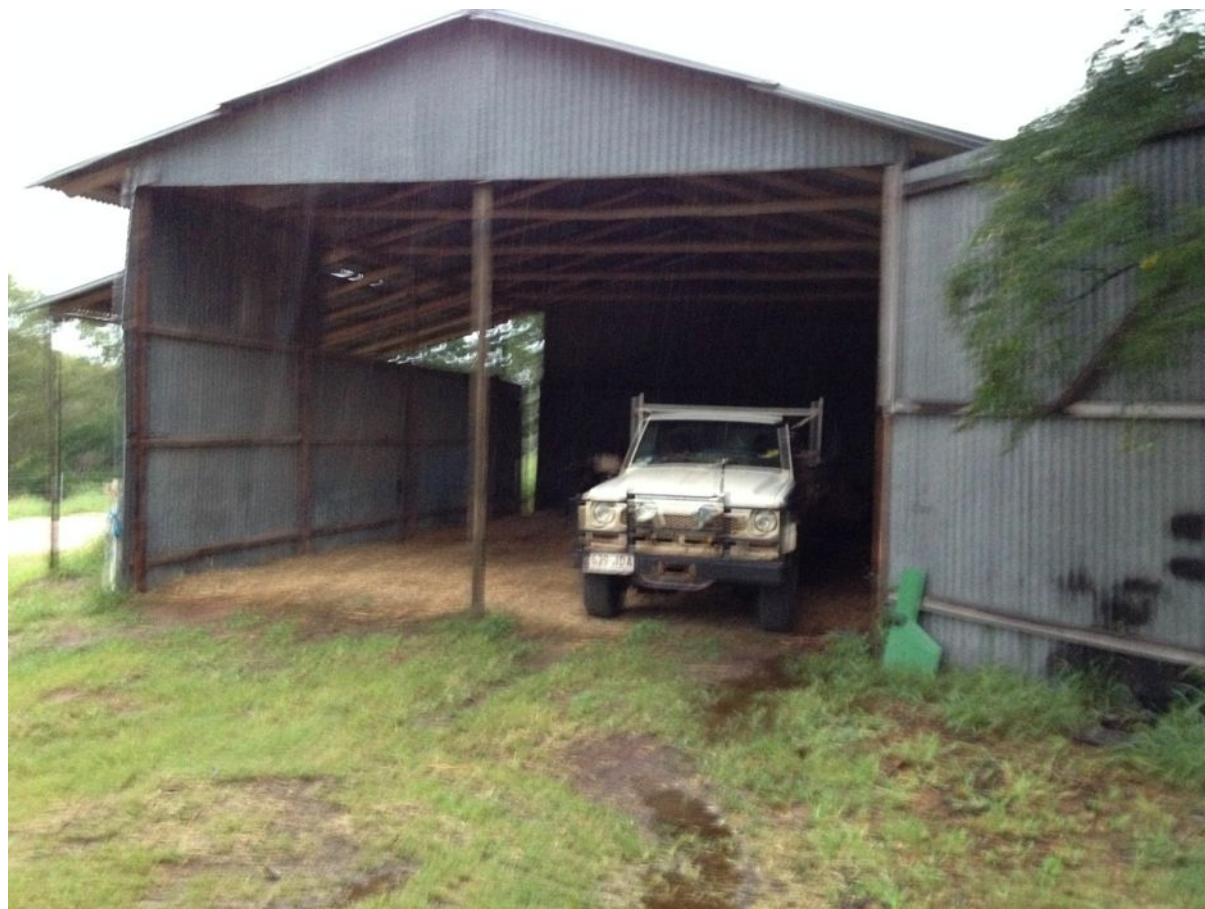
**AHIR 140414-61 Concrete, Tin & Timber Shed**

Description: Tin and Bush Timber Shed

No evidence of asbestos containing materials.

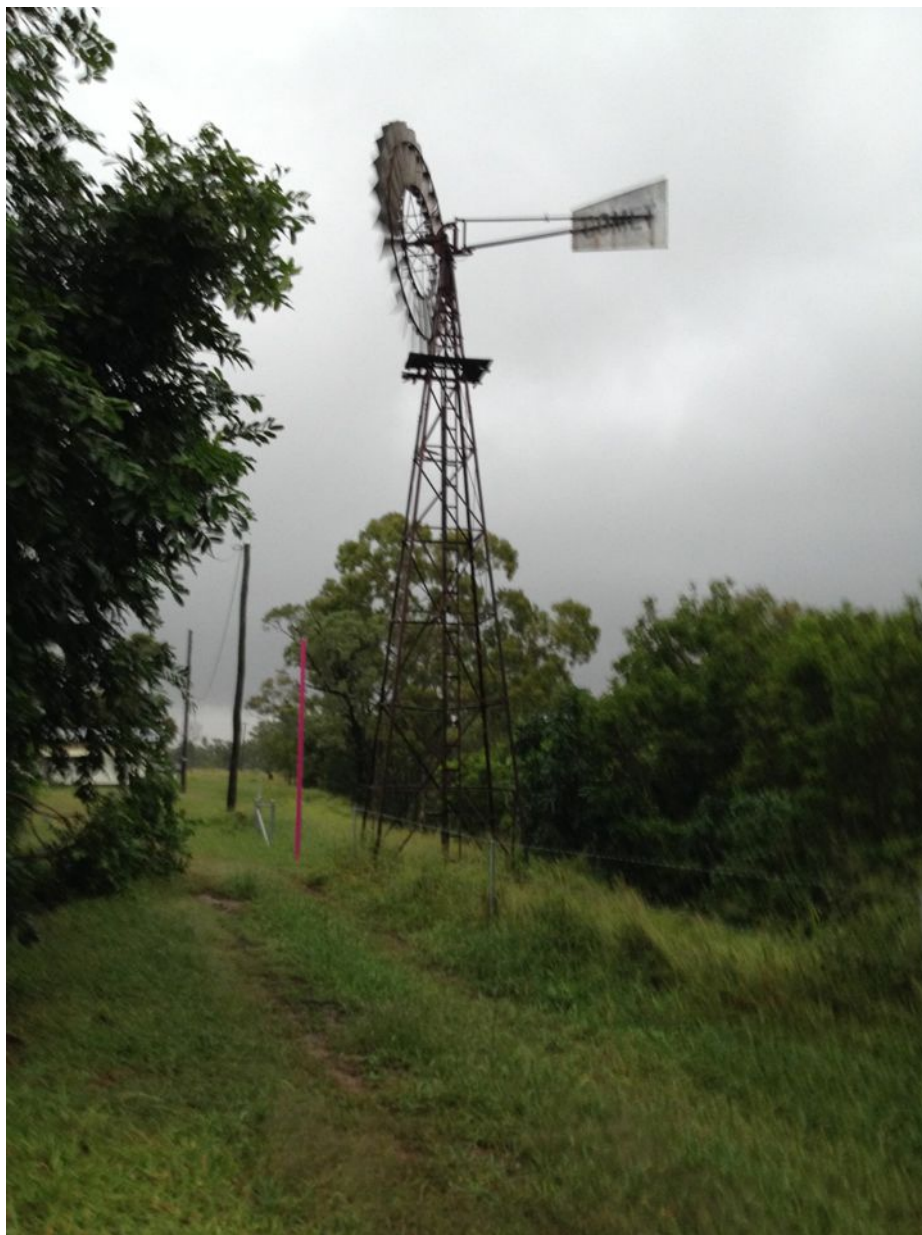
### **AHIR 140414-63 Concrete and Steel Windmill**

Description: Steel and Concrete Windmill

No evidence of asbestos containing materials.

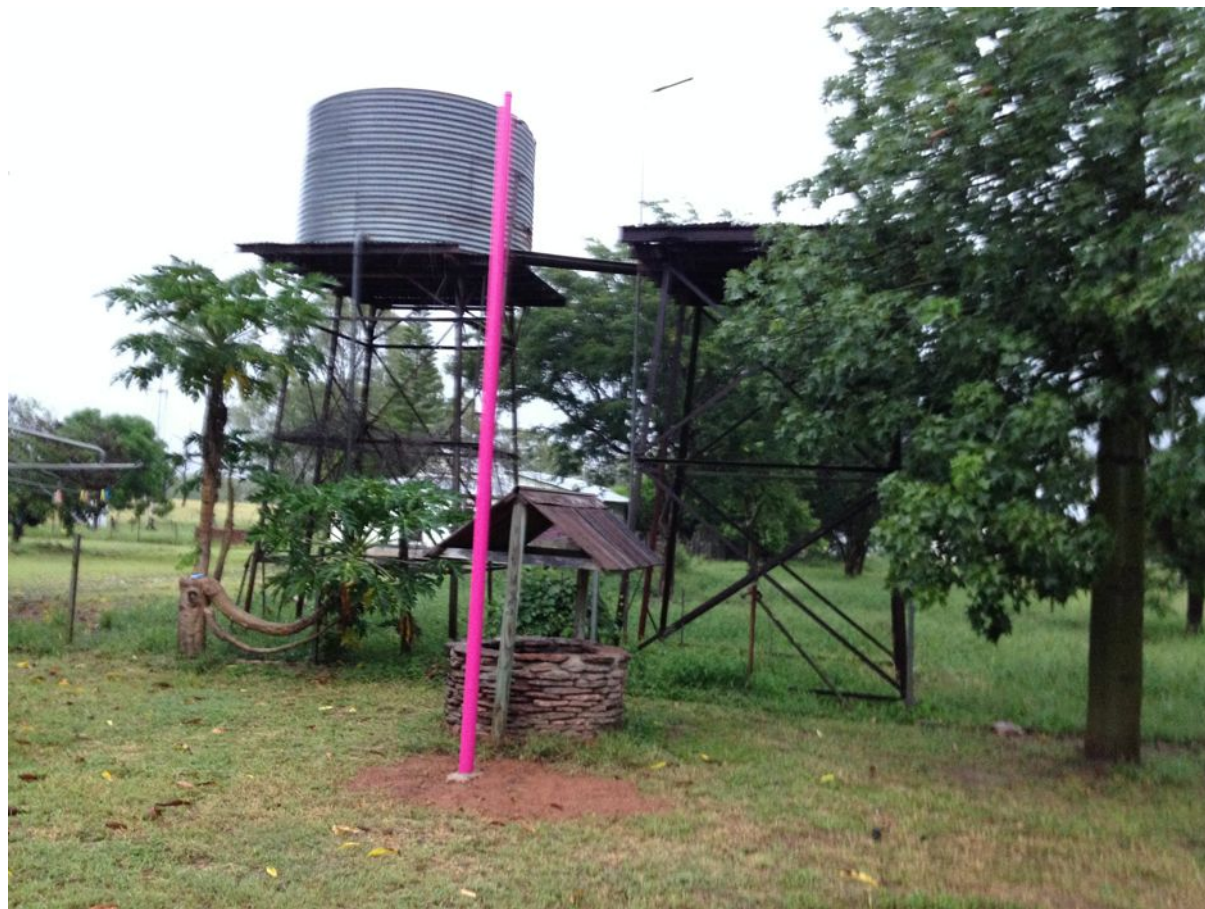
**AHIR 140414-64 Concrete, Steel, Tin Water Storage**

Description: Water Storage, Homestead

No evidence of asbestos containing materials.

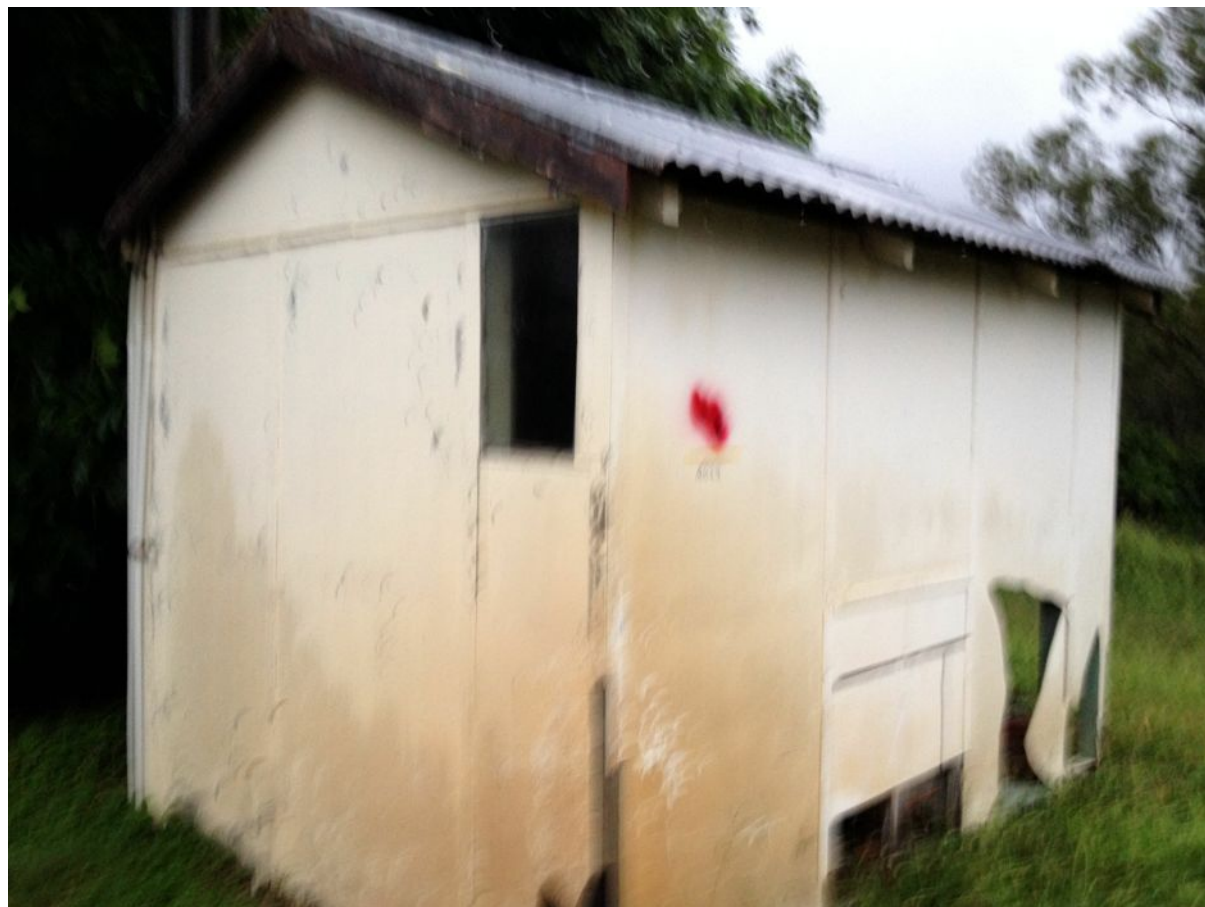
**AHIR 140414-65 Bore Shelter, Homestead**

Description: Bore Shelter, Homestead

Sample A023 Evidence of asbestos containing materials:

Grey compressed fibre cement material, Chrysotile asbestos detected.

It is for this reason that the ACMs must be removed before any construction or demolition works are undertaken.

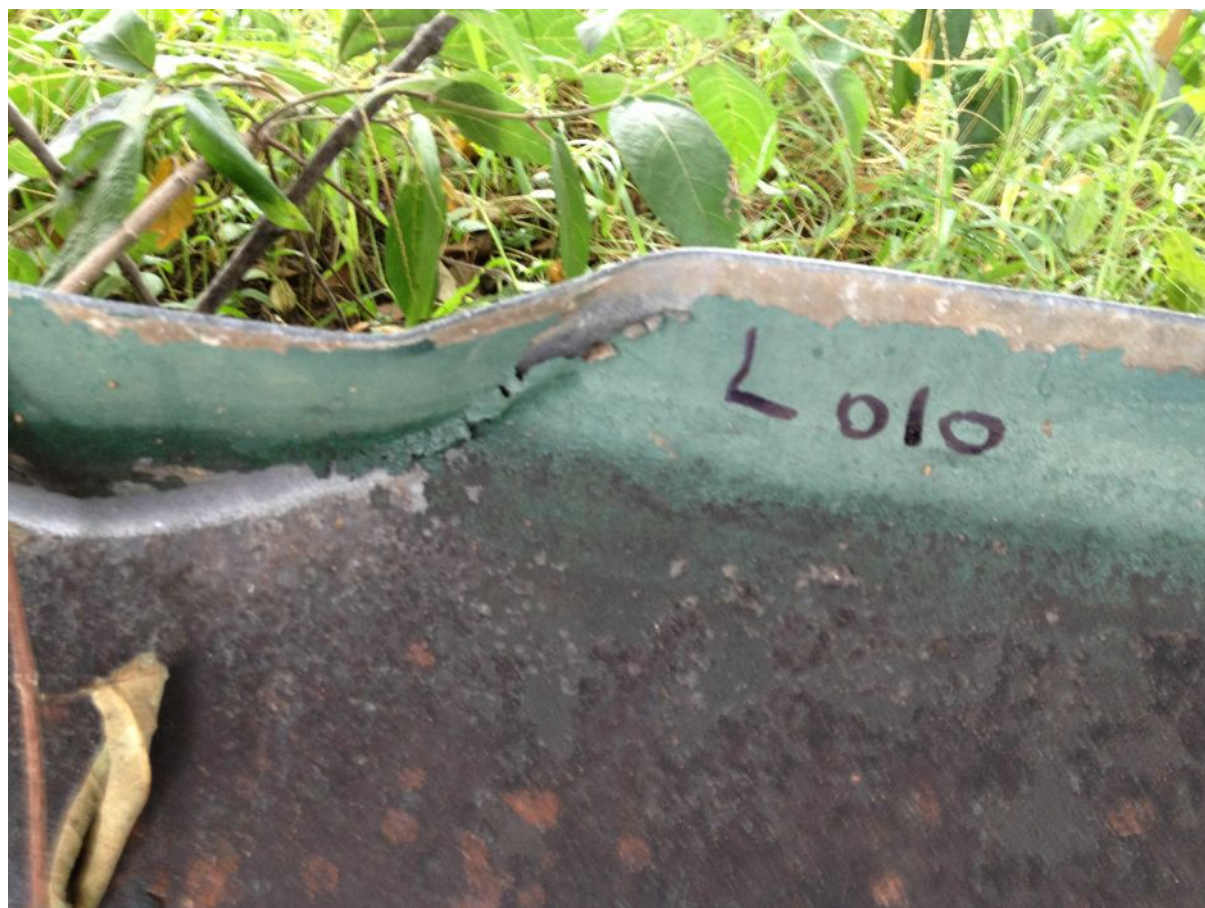
#### **AHIR 140414-57 Water Trough (Lead < 0.05 %)**

Description: iron water trough

Sample 110213-10 (Enviroics reference L010):

Green paint- %w/w <0.05
