# **Asbestos Assessor's Report:** **TFTA (0233) CF3 P2** **Fanning River Integration – HOUSE ONE**

The site of the works is located at Townsville Field Training Area – Fanning River Station.

The aim of this project was to carry out an asbestos and lead in paint survey on buildings and structures to ascertain if asbestos containing materials are present prior to demolition works scheduled to be carried out.

Environics, 12<sup>th</sup> June 2014 – Report Number 140612-1 Rev0

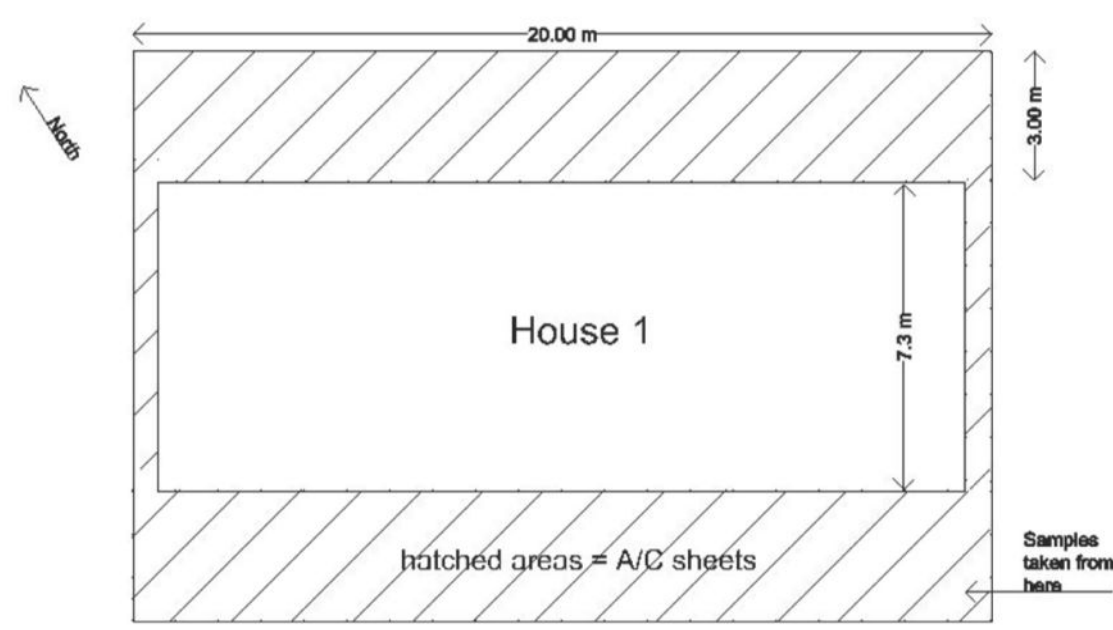
<p>Cert. of Analysis: 110214 Lab. Refer: 110214-1 Environics Refer: A001</p>				<p><b>Lead in Paint</b> %w/w <input type="text"/> Area m2: <input type="text"/></p>		
<p>Asbestos Detected - Yes: <input checked="" type="checkbox"/> No: <input type="checkbox"/> Asbestos</p> <p>If Detected, What Type: Chrysotile &amp; Amosite</p> <p>Sample Description: Area m2: 128</p> <p>Pink fibre cement material</p>										
Asbestos Assessor: Lawrie Lyons (Environics)				Drawings & Illustrations

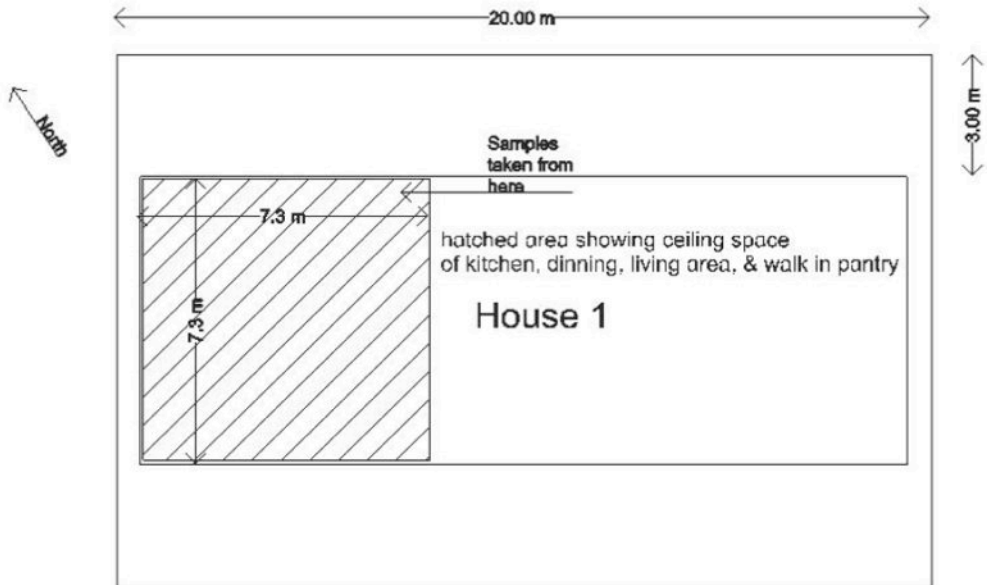
## 1.2. AHIR 140414-4 Kitchen/Dinning/Living

Condition:	Fair	Internal ceilings of the kitchen, dinning area, living room, and walk in pantry at the northern end of the house.

Asbestos Detected - Yes:	<input checked="" type="checkbox"/>	No:	<input type="checkbox"/>	<b>Asbestos</b>
If Detected, What Type:	Chrysotile & Amosite			
Sample Description:	Area m2: 34			
Grey compressed fibre cement material

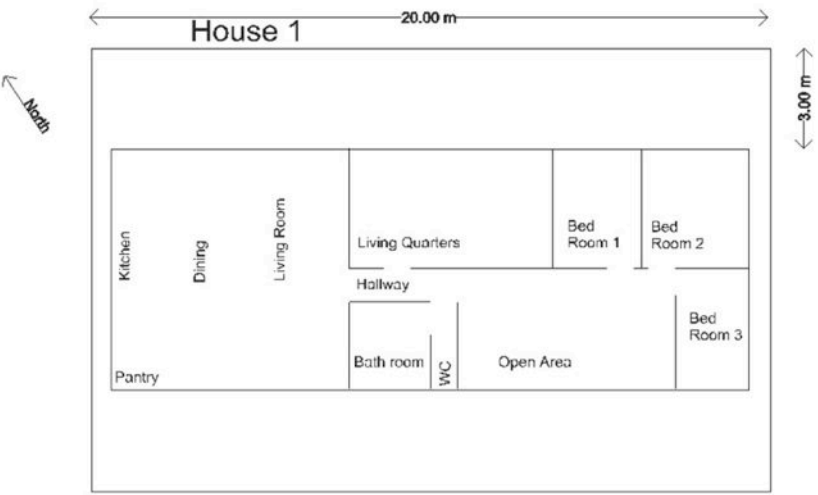
## 1.13. AHIR 140414-16A Living Quarters

Condition:	Fair	Masonite Timber walls and Timber floors partly covered with vinyl Ceiling is A/C sheets same as Kitchen/Living Area			
Photo Caption:	Ceilings and Walls	Laboratory:	Envirolab Services Pty Ltd

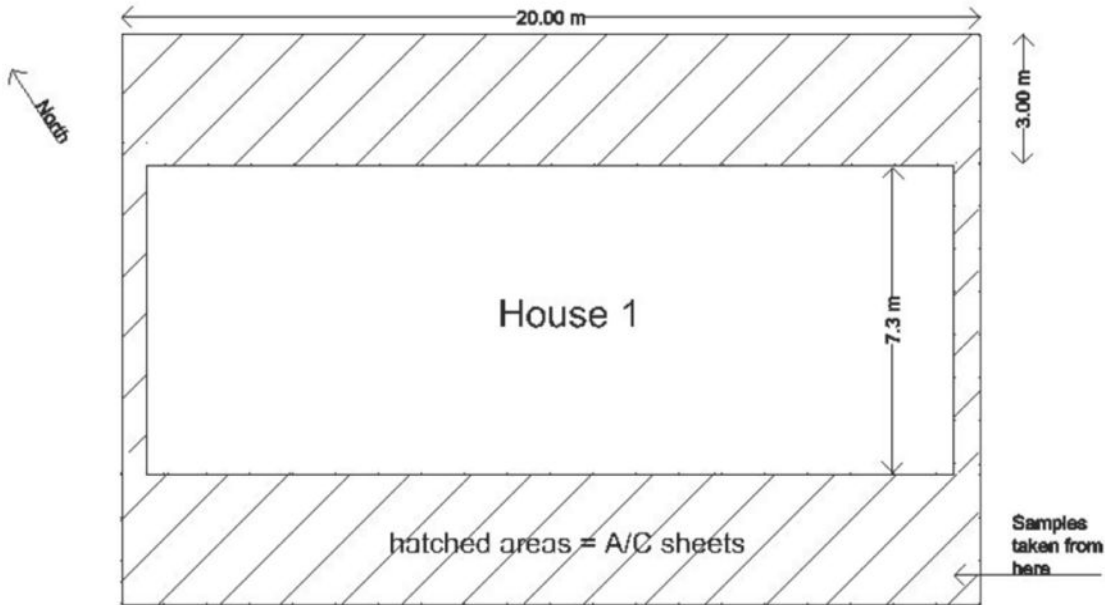
Cert. of Analysis:		110213		
AHIR 140414-1 (asbestos ID) AHIR 140414-2 (lead in paint)				Lab. Refer:		110213-1		
				Enviroics Refer:		L001		
				Lead in Paint				
				%w/w		0.3		
				Area m2:		128		
				Asbestos Detected - Yes: <input type="checkbox"/> No: <input type="checkbox"/>		Asbestos		
				If Detected, What Type:				
				Sample Description:		Area m2: <input type="text"/>		
Asbestos Assessor:				Lawrie Lyons (Enviroics)				
				Drawings & Illustrations

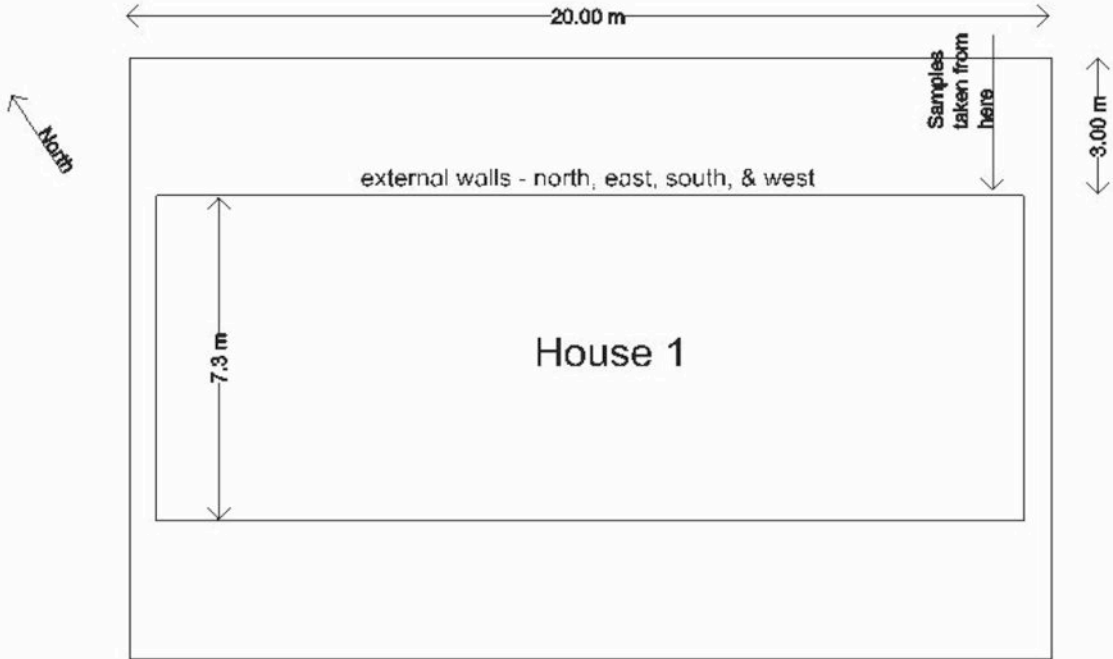
Cert. of Analysis:	110213		
				Lab. Refer:			
				Envionics Refer:	L002		
				<b>Lead in Paint</b> %w/w < 0.05 Area m2: 151			
				Asbestos Detected - Yes: <input type="checkbox"/> No: <input type="checkbox"/> <b>Asbestos</b> If Detected, What Type: <input type="text"/> Sample Description: <input type="text"/> Area m2: <input type="text"/>			
Asbestos Assessor: Lawrie Lyons (Envionics)				Drawings & Illustrations
