Asbestos Assessor's Report:

TFTA (0233) CF3 P2

Fanning River Integration – COTTAGE ONE

Environics, 12th June 2014 – Report Number 140612-2 Rev0

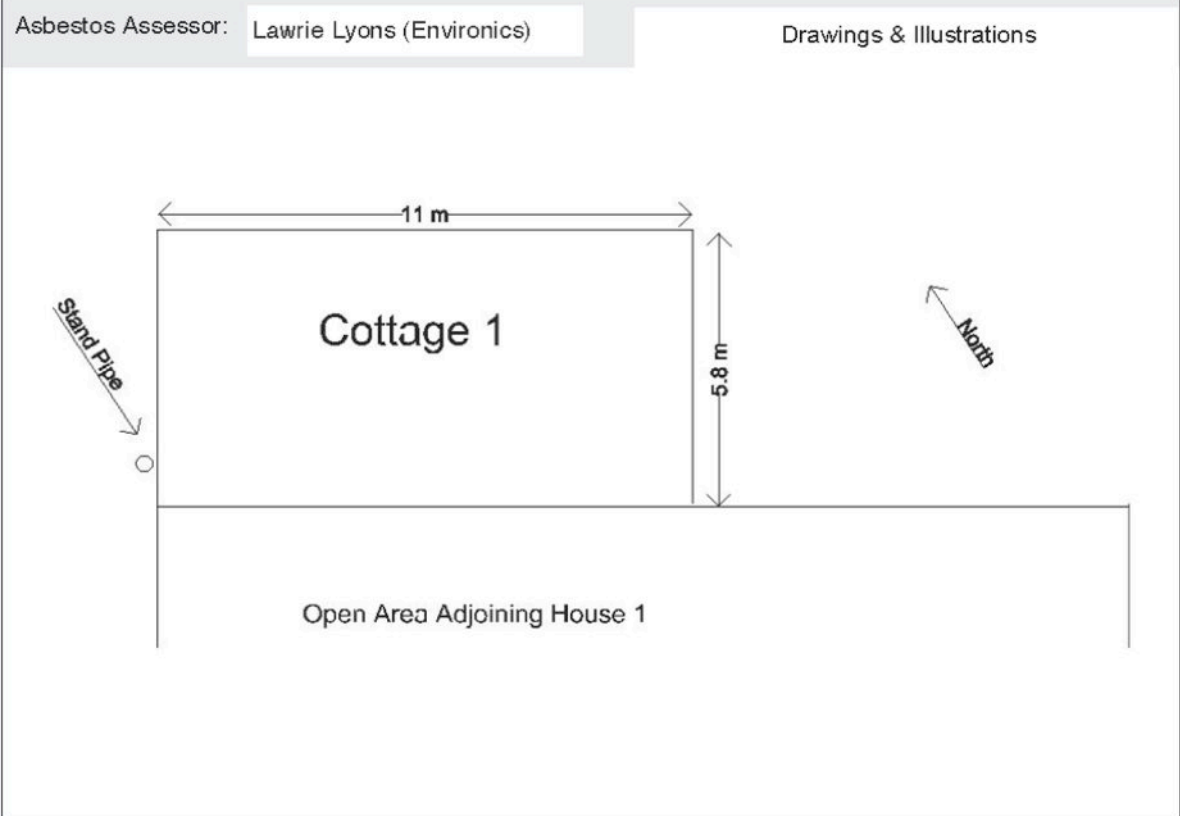
Frangible:	Bonded:	<input checked="" type="checkbox"/>	Not Detected:	<input type="checkbox"/>	References / Attachments / Comments:						
Condition:	Fair	Upright pipe attached to north west wall of cottage									
Photo Caption:	A/C stand pipe			Laboratory:	Envirolab Services Pty Ltd

Cert. of Analysis:	110214		Lead in Paint				
				Lab. Refer:	110214-4		%w/w				
				Enviroics Refer:	A004		Area m2:				
				Asbestos Detected - Yes:	<input checked="" type="checkbox"/>	No:	<input type="checkbox"/>	Asbestos			
				If Detected, What Type:	Chrysotile						
				Sample Description:	Area m2:		4				
				Grey compressed fibre cement material							
Asbestos Assessor:				Lawrie Lyons (Enviroics)			Drawings & Illustrations

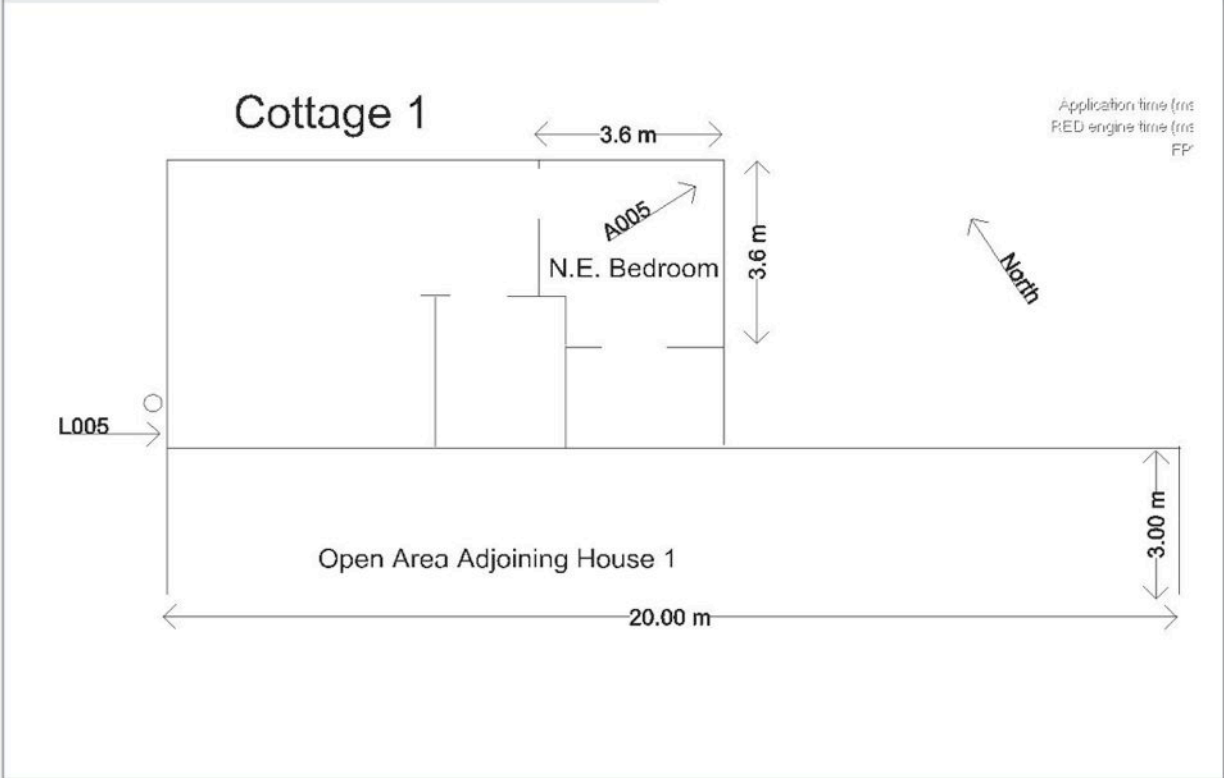
1.3. AHIR 140414-20 Ceiling of North East Bedroom

Region:	NQ - NQ	Property:	TFTA (0233) CF3 P2 Fanning River Integration	Structure:	Cottage 1
AHIR:	140414-20	Level:	Survey	Location:	GR 25.883 43.850
Space:	External Area				
ACM:	Chrysotile & Amosite	Estate Details:	Townsville Field Training Area, Fanning River Station.		ACM MGT:
Remove for demolition					
Secondary Location:	N.E. bedroom	Quantity (m2):	13	Occupancy In Use:	<input type="checkbox"/> No In Use: <input checked="" type="checkbox"/>
Application:	Ceiling	Control - Encapsulate:	<input type="checkbox"/> Leave and Manage:	<input type="checkbox"/> Remove:	<input checked="" type="checkbox"/> N/A: <input type="checkbox"/> Other: <input type="text"/>
ACM Status:	Detected: <input checked="" type="checkbox"/> Friable: <input type="checkbox"/> Bonded: <input checked="" type="checkbox"/> Not Detected: <input type="checkbox"/>	Labels -	Applied: <input checked="" type="checkbox"/> Remove: <input type="checkbox"/> Required: <input type="checkbox"/>	Sample ID #:	<input type="text"/>

Cert. of Analysis: 110214 Lab. Refer: 110214-5 Envirionics Refer: A005		
			Lead in Paint %w/w <input type="text"/> Area m2: <input type="text"/>		
			Asbestos Detected - Yes: <input checked="" type="checkbox"/> No: <input type="checkbox"/> Asbestos If Detected, What Type: Chrysotile & Amosite Sample Description: Area m2: 13 Grey fibre cement material		
Asbestos Assessor: Lawrie Lyons (Envirionics)			Drawings & Illustrations

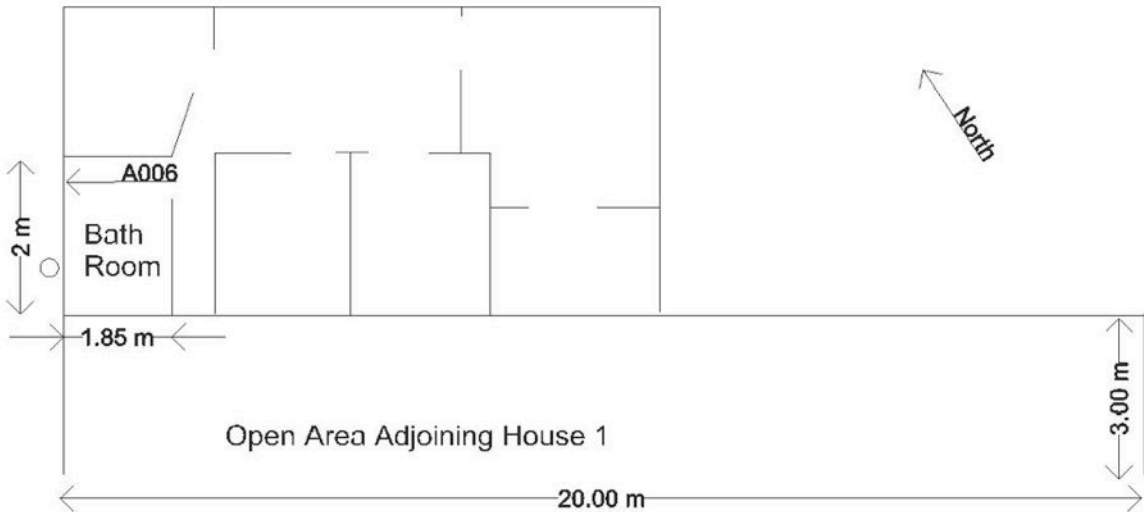
1.4. AHIR 140414-21 Bathroom Walls

Region:	NQ - NQ	Property:	TFTA (0233) CF3 P2 Fanning River Integration		Structure:	Cottage 1	
AHIR:	140414-21	Level:	Survey	Location:	GR 25.883 43.850	Space:	Internal Area
AHIR	ACM:	Chrysotile	Estate Details:	Townsville Field Training Area, Fanning River Station.		ACM MGT:	Remove for demolition
Secondary Location:	Bathroom	Quantity (m2):	18	Occupancy In Use:	<input type="checkbox"/>	No In Use:	<input checked="" type="checkbox"/>
Application:	Walls	Control - Encapsulate:	<input type="checkbox"/>	Leave and Manage:	<input type="checkbox"/>	Remove:	<input checked="" type="checkbox"/>
ACM Status:	Detected:	<input checked="" type="checkbox"/>	Labels -	Appixed:	<input checked="" type="checkbox"/>	Remove:	<input type="checkbox"/>
Friable:	<input type="checkbox"/>	Bonded:	<input checked="" type="checkbox"/>	Not Detected:	<input type="checkbox"/>	Required:	<input type="checkbox"/>
Condition:	Fair	Sample ID #: A006

Cert. of Analysis:	110214		
				Lab. Refer:	110214-6		
				Enviroics Refer:	A006		
				Lead in Paint			
				%w/w	<input type="text"/>		
				Area m2:	<input type="text"/>		
Asbestos Detected - Yes: <input checked="" type="checkbox"/> No: <input type="checkbox"/> Asbestos							
If Detected, What Type: Chrysotile							
Sample Description: Area m2: 18							
Grey fibre cement material							
Asbestos Assessor: Lawrie Lyons (Enviroics)							
Drawings & Illustrations							
<p>Cottage 1</p> <p>Application to RED engine ti</p>

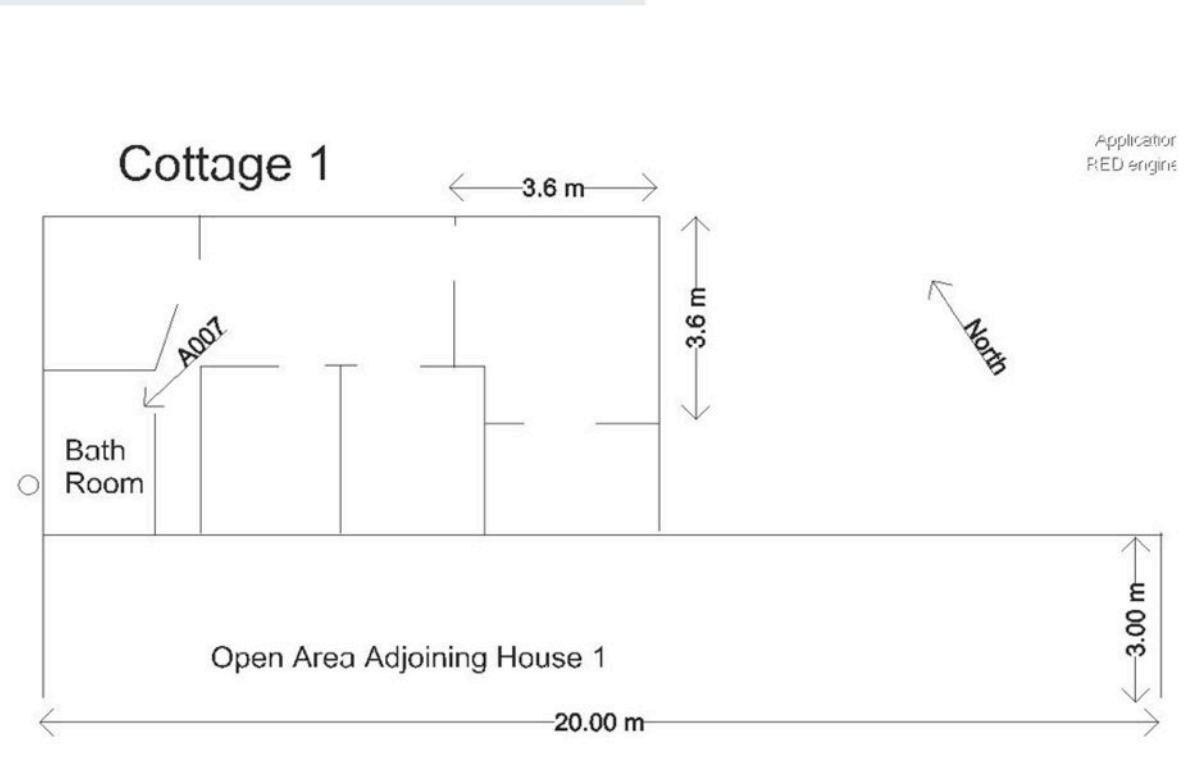
1.5. AHIR 140414-22 Bathroom Floor

Region:	NQ - NQ	Property:	TFTA (0233) CF3 P2 Fanning River Integration		Structure:	Cottage 1	
AHIR:	140414-22	Level:	Survey	Location:	GR 25.883 43.850	Space:	Internal Area
AHIR	ACM:	Chrysotile	Estate Details:	Townsville Field Training Area, Fanning River Station.		ACM MGT:	Remove for demolition
Secondary Location:	Bathroom	Quantity (m2):	3.6	Occupancy In Use:	<input type="checkbox"/>	No In Use:	<input checked="" type="checkbox"/>
Application:	Floors	Control - Encapsulate:	<input type="checkbox"/>	Leave and Manage:	<input type="checkbox"/>	Remove:	<input checked="" type="checkbox"/>
ACM Status:	Detected:	<input checked="" type="checkbox"/>	Labels -	Appixed:	<input checked="" type="checkbox"/>	Remove:	<input type="checkbox"/>
Friable:	<input type="checkbox"/>	Bonded:	<input checked="" type="checkbox"/>	Not Detected:	<input type="checkbox"/>	Required:	<input type="checkbox"/>
Condition:	Fair	Sample ID #: A007

Cert. of Analysis:	110214		
				Lab. Refer:	110214-7		
				Enviroics Refer:	A007		
				Lead in Paint %w/w <input type="text"/> Area m2: <input type="text"/>			
Asbestos Detected - Yes: <input checked="" type="checkbox"/> No: <input type="checkbox"/>				Asbestos			
If Detected, What Type:				Chrysotile			
Sample Description:				Area m2:		3.6	
Beige brittle vinyl tile							
Asbestos Assessor:				Lawrie Lyons (Enviroics)			
Drawings & Illustrations
