# Asbestos Assessor's Report:

TFTA (0233) CF3 P2  
Fanning River Integration – WORKSHOP

Environics, 12<sup>th</sup> June 2014 – Environics-rpt-140612-3-rev0

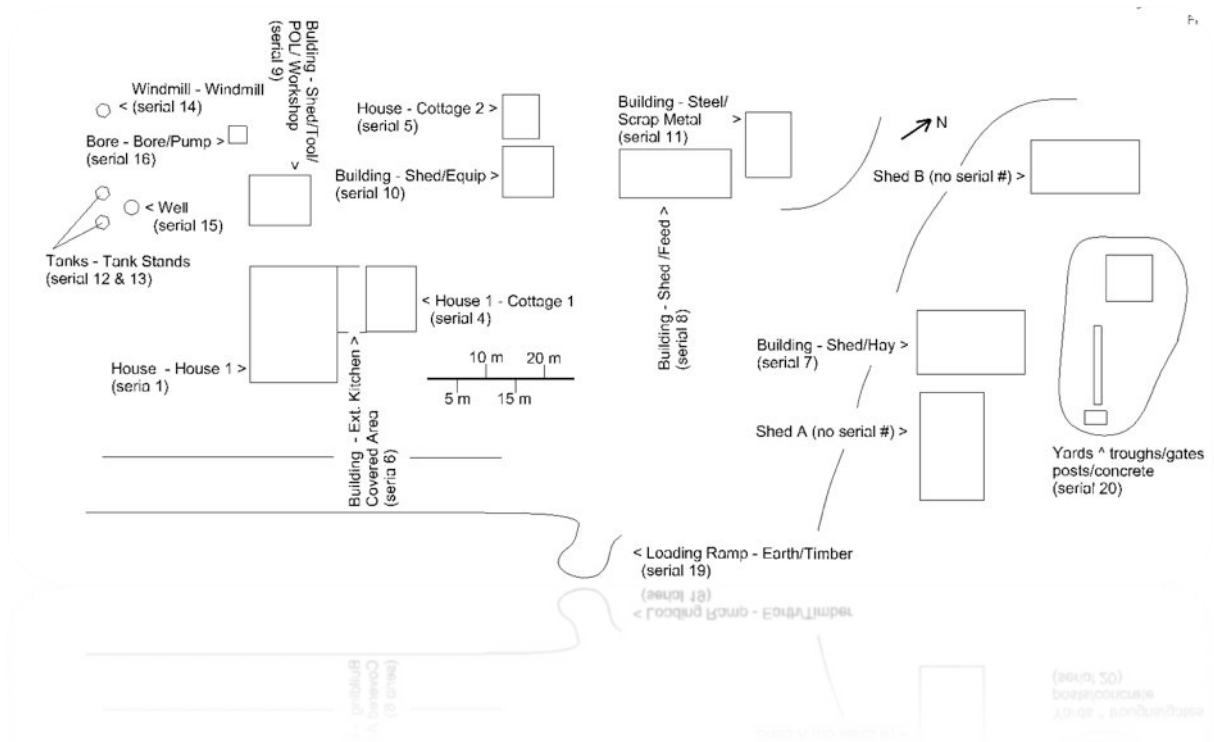
### **2.1. Drawing - Homestead Site Plan (Primary)**

Shown on the following page are the primary buildings and structures of the homestead. Serial 9 on the drawing is the subject building, Workshop.

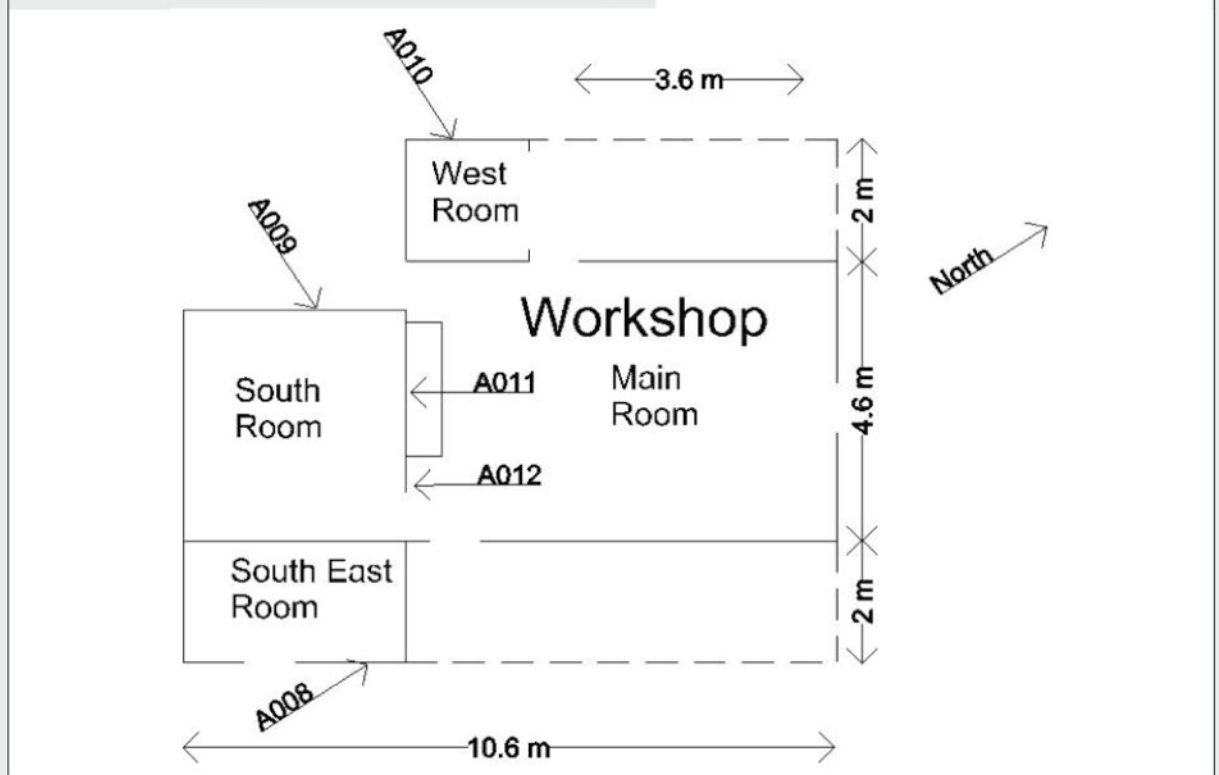
| Condition: | Poor | South East Room of Workshop | | | | | | | | | |

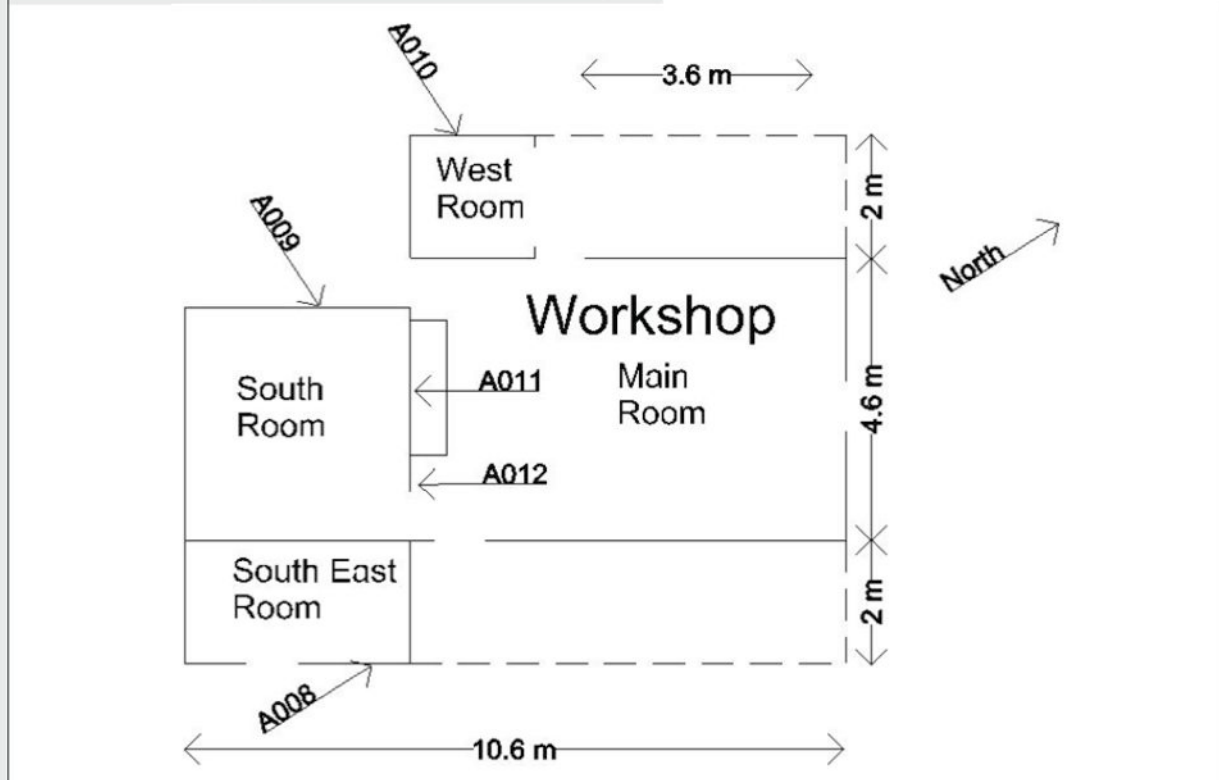
## 1.2. AHIR 140414-26 West Walls of South Room

| Condition: | Poor | Sample ID #: | A009 | | |

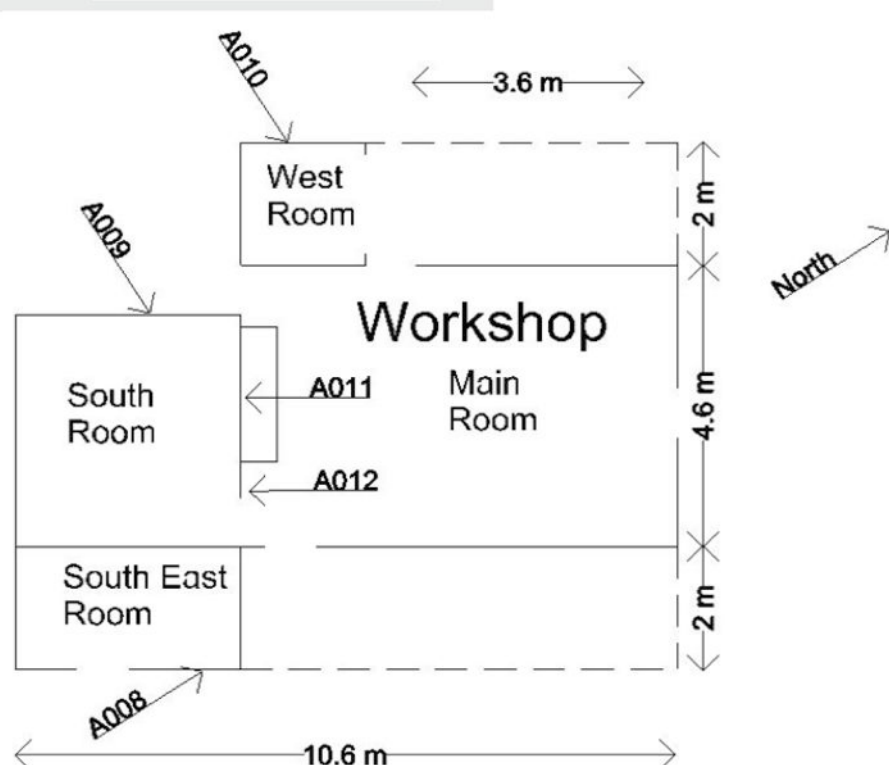
### 1.3. AHIR 140414-27 Wall of West Room

| Condition: Poor | | | | | | | | |

| Grey compressed fibre cement material | | |

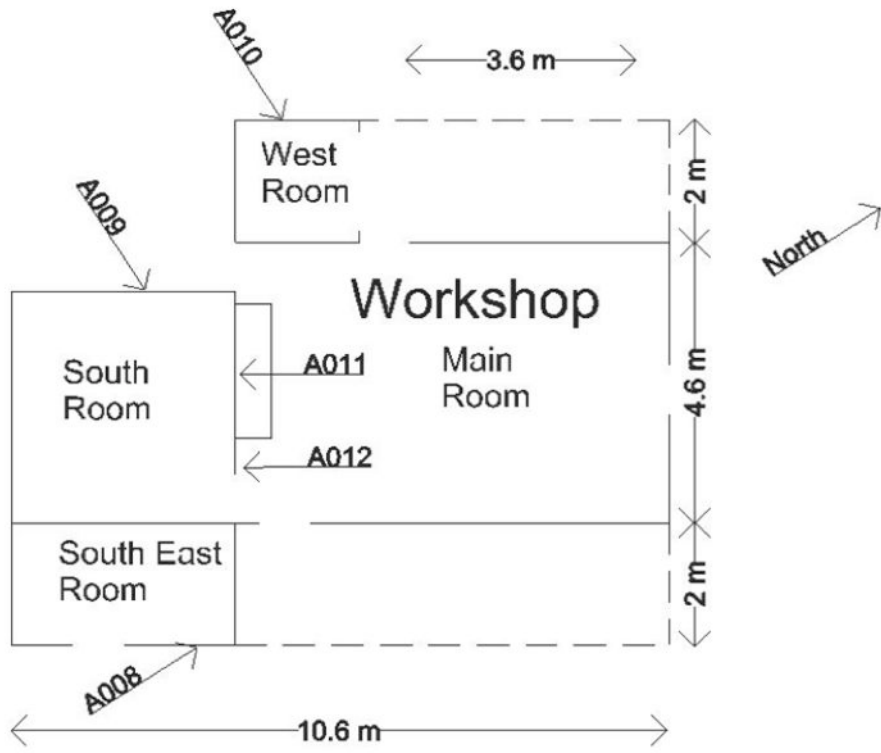
## 1.5. AHIR 140414-29A Ceilings of Main Room

| Grey compressed fibre cement material | |

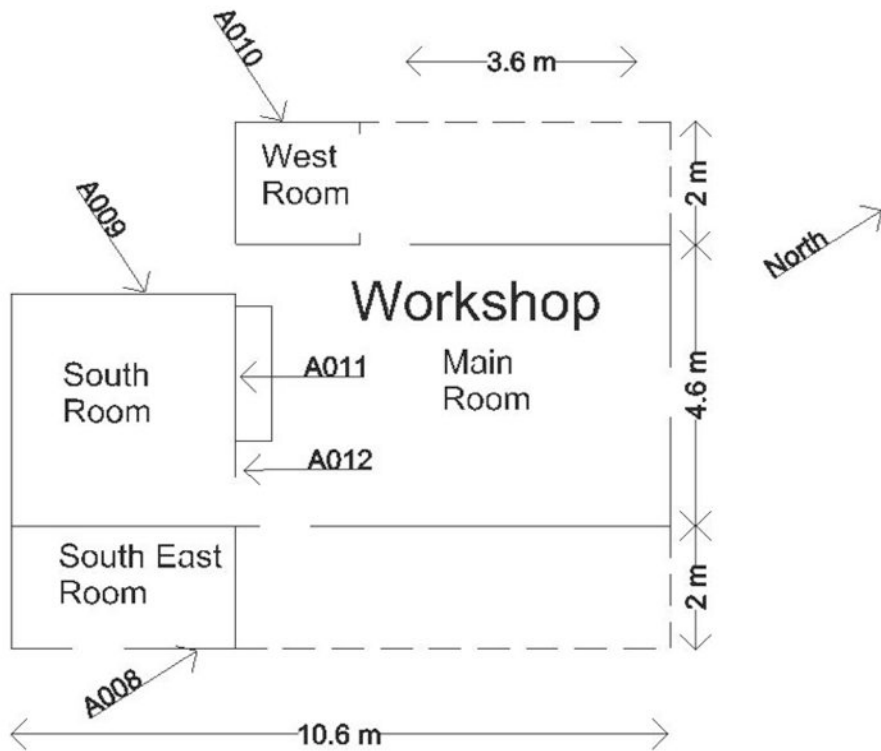
## 1.6. AHIR 140414-30 Wall Panel, Work Bench, Main Room

| Condition: | Poor | On the south side of the main room is a work bench and above the bench is a panel of A/C sheet. | | | | | | | | | |

| Grey compressed fibre cement material | | | | |

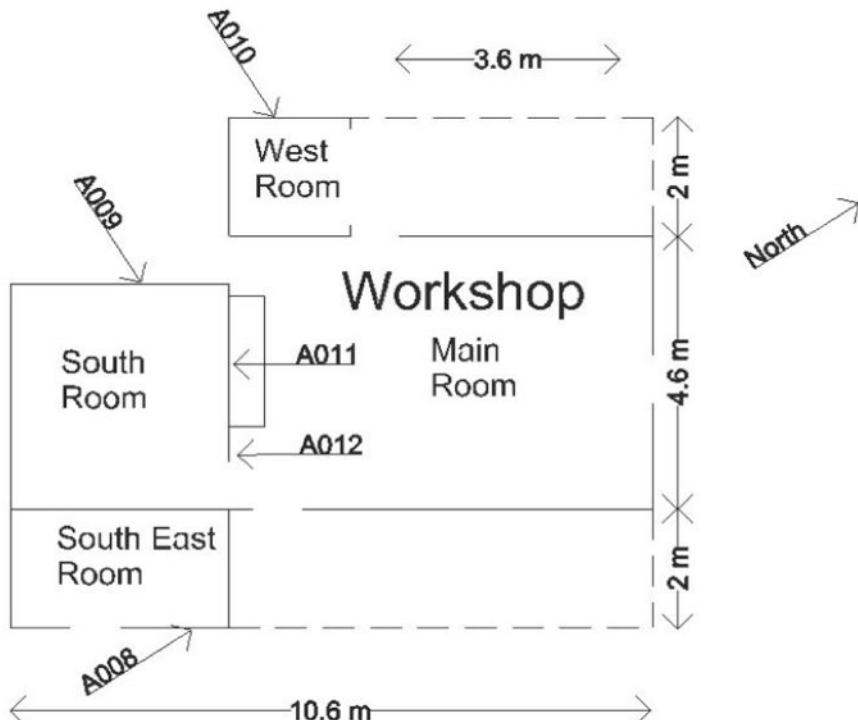
| Condition: | Poor | Ceilings of Main Room are Masonite - the cream paint is the same as house 1 that was found to contain lead in very low concentration. | | | | | | | | | |
