Reference: NO21608.16

# **Asbestos Assessor's Report:**

## **TFTA (0233) CF3 P2**

### **Fanning River Integration – HOUSE TWO**

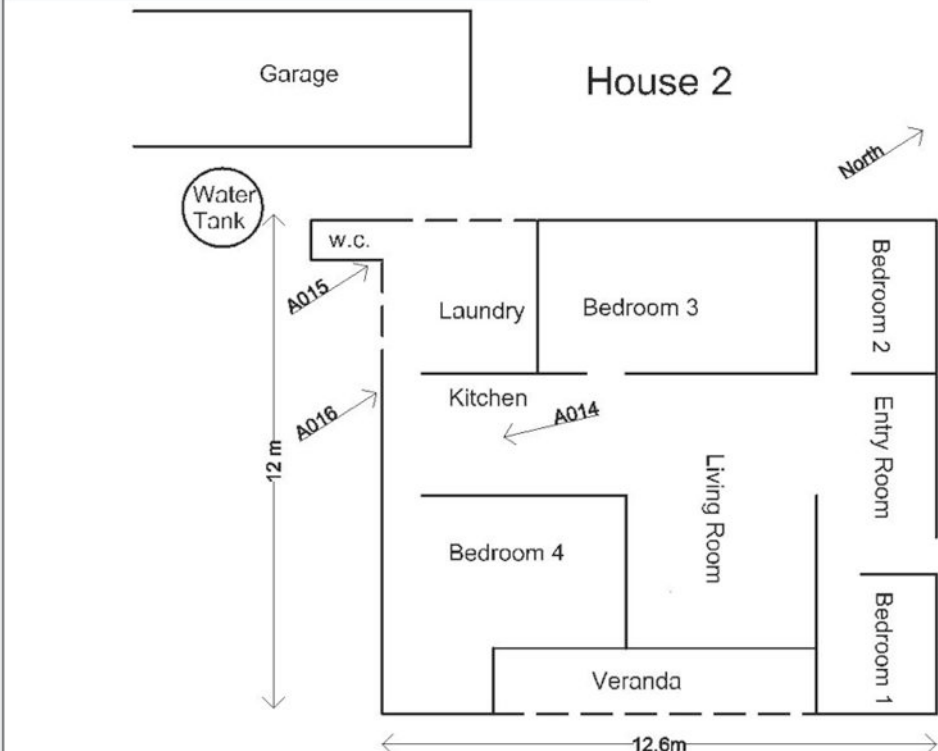
| Condition: | Poor | | Sample taken from north east wall | | | | | | | | | |
| Grey compressed fibre cement material | | | | | | | | | | | | |

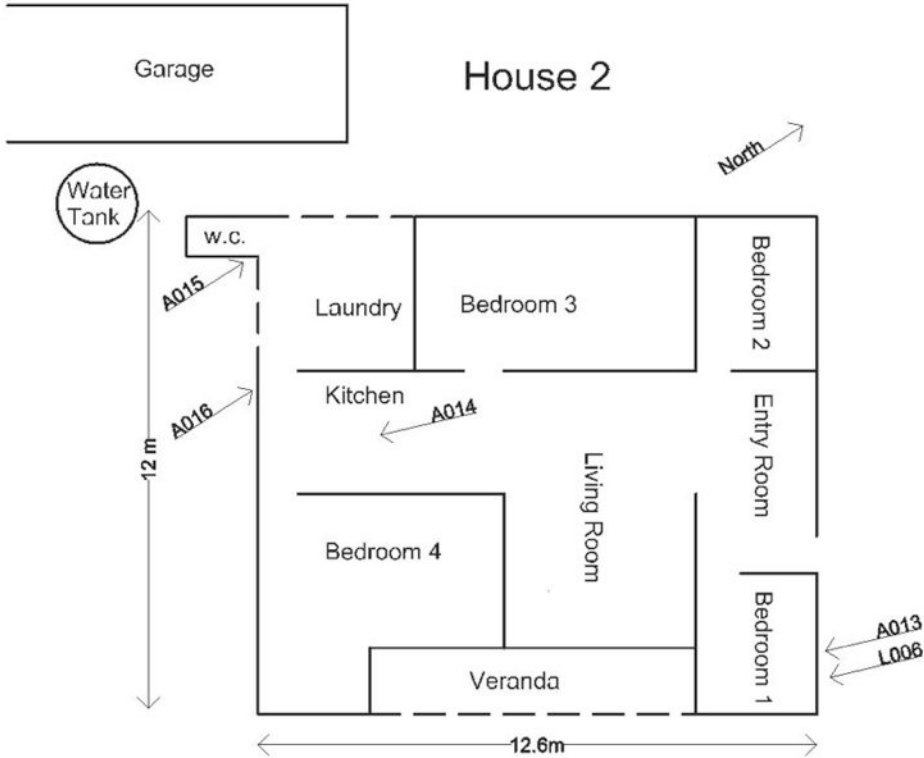
## 1.2. AHIR 140414-34 Internal Lining Sheets (Walls)

| Condition: | Poor | References / Attachments / Comments: | | | | | |
| Internal walls and ceilings found to be Masonite, floors under vinyl found to be timber | | | | | | | |

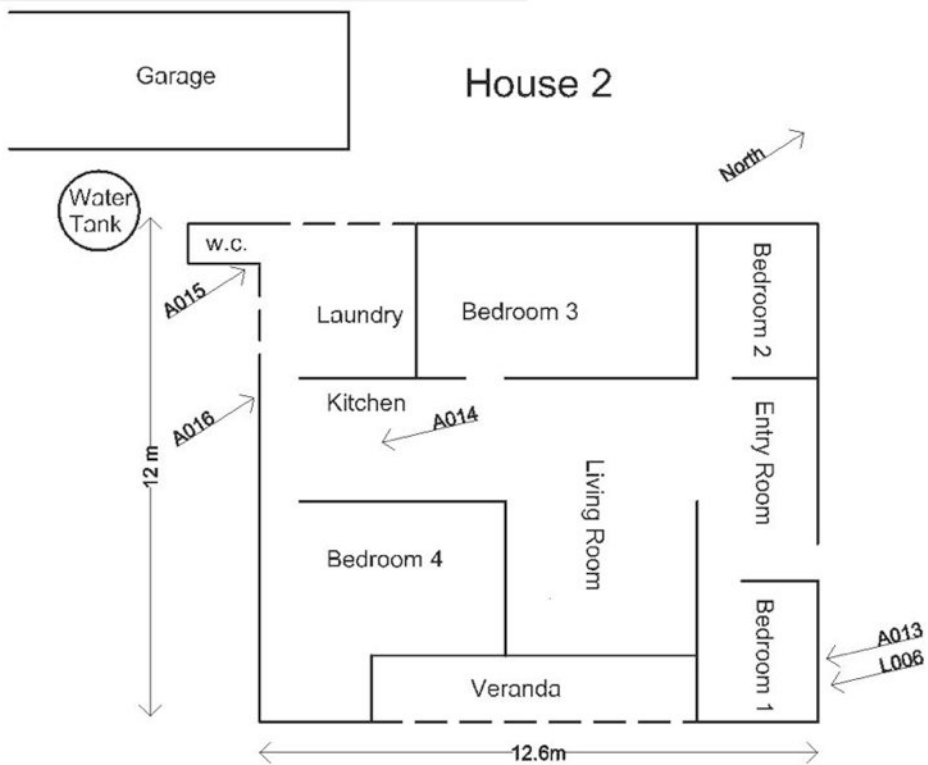
### 1.3. AHIR 140414-35 Kitchen Floors

| Condition: | Poor | | | | | | | | | | |

| Millboard backed beige vinyl sheet | | | | |

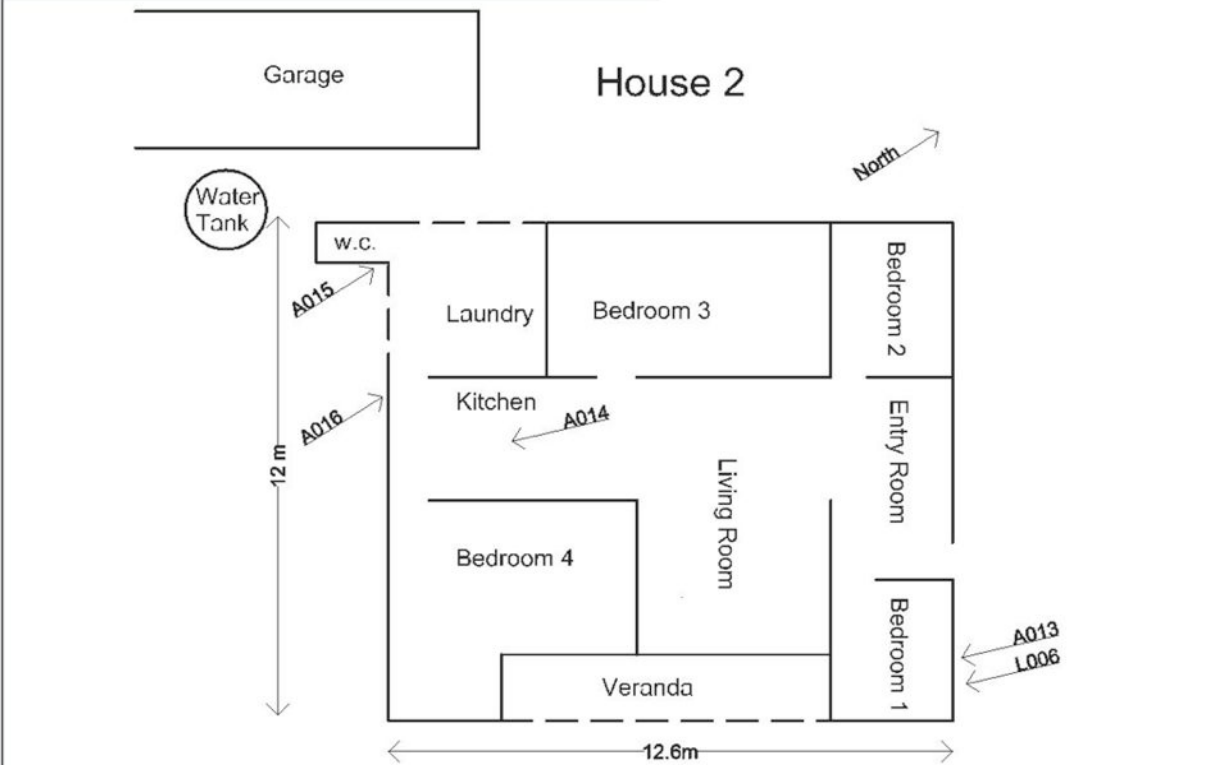
## 1.5. AHIR 140414-37 External Sheets of House Extension

| Condition: | | Poor | | | | | |
| | | | | Grey compressed fibre cement material | | | |

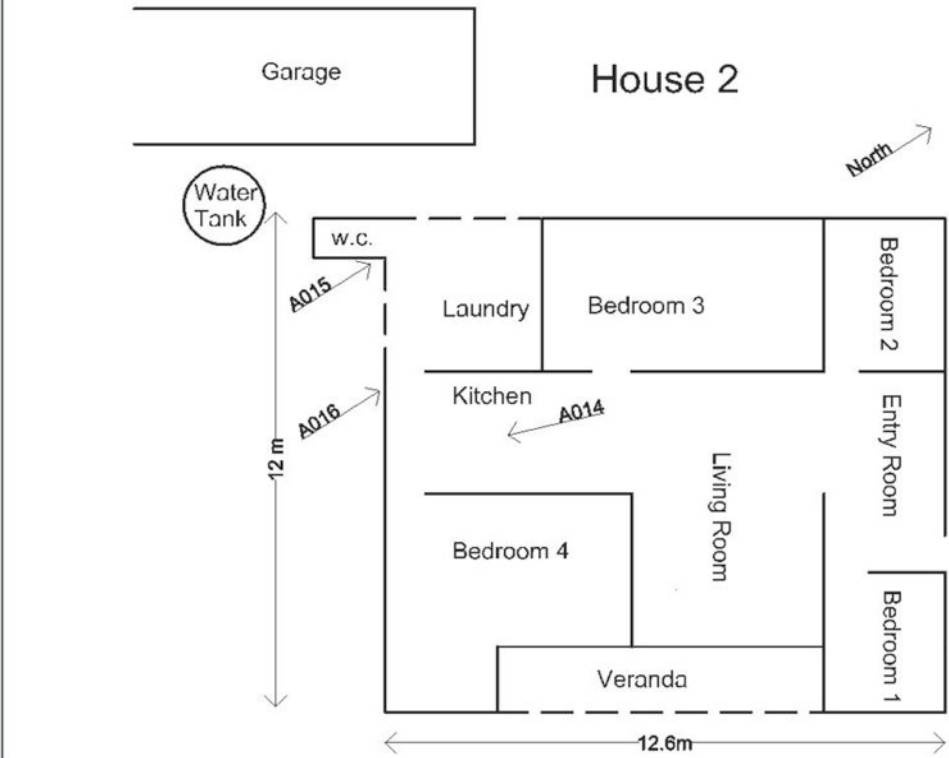
| Condition: | Poor | | Section running south west to north east above the roof of the main section of the house where an extension has been made to the north. | | | | | | |
| | | | Grey compressed fibre cement material | | | | | | |
