# **Asbestos Assessor's Report:**

## **TFTA (0233) CF3 P2**

### **Fanning River Integration – HOUSE THREE**

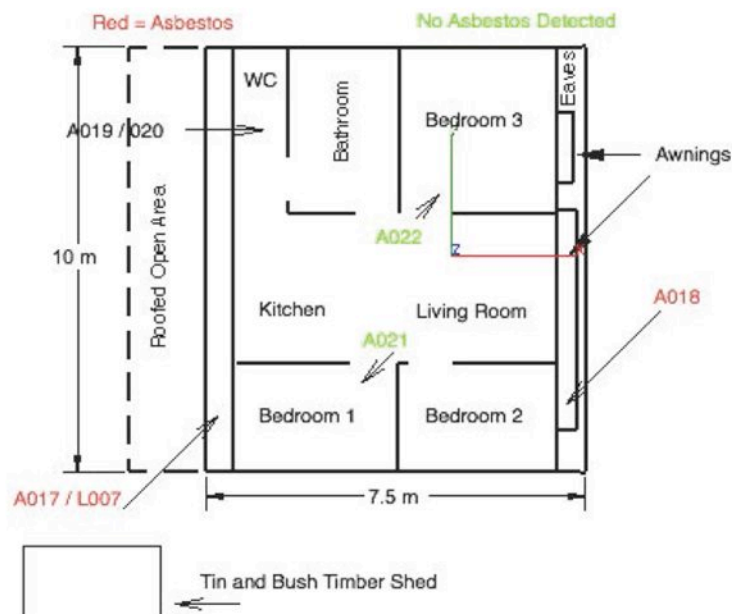
### House 3

Friable:	<input type="checkbox"/> Bonded:	<input checked="" type="checkbox"/>	Not Detected:	<input type="checkbox"/>	References / Attachments / Comments:				
Condition:	Poor	Sample taken from south east eave of house.

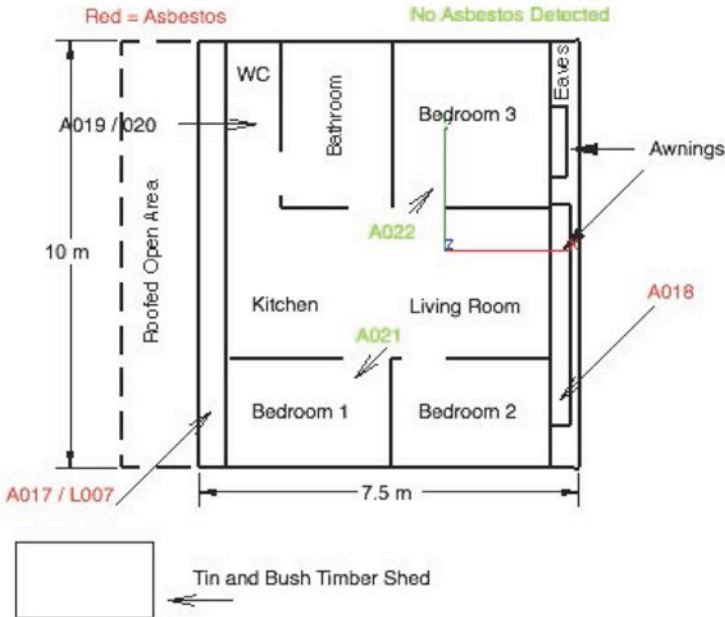
Condition:	Poor		Grey brittle vinyl tile contains asbestos however the underlying adhesive contains no asbestos (refer to laboratory results for more details).					
Photo Caption:	A019 Sample Location		Laboratory:				Envirolab Services Pty Ltd

Cert. of Analysis:	110214		Lead in Paint		
			Lab. Refer:	110214-19		%w/w	<input type="text"/>	
			Enviroics Refer:	A019		Area m2:	<input type="text"/>	
			Asbestos Detected - Yes: <input checked="" type="checkbox"/> No: <input type="checkbox"/> Asbestos					
			If Detected, What Type:		Chrysotile			
			Sample Description:		Area m2: 2			
			Grey compressed fibre cement material					
Asbestos Assessor:			Lawrie Lyons (Enviroics)		Drawings & Illustrations			
<p><b>House 3</b></p> <p>Red = Asbestos      No Asbestos Detected</p>

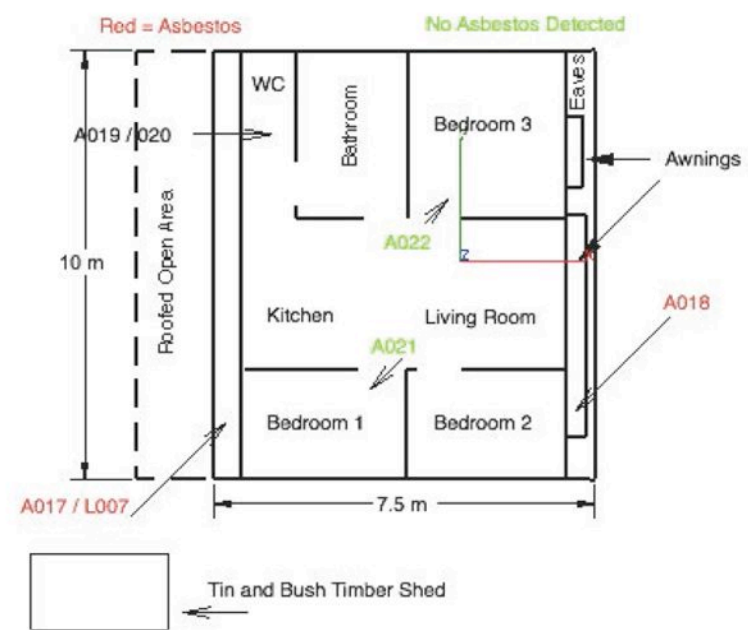
Asbestos Detected - Yes:	<input type="checkbox"/> No:	<input checked="" type="checkbox"/> <b>Asbestos</b>
If Detected, What Type:		
Sample Description:	Area m2:	18
Fibrous bituminous backed vinyl

Asbestos Assessor:	Lawrie Lyons (EnviroLab)	Drawings & Illustrations
<p><b>House 3</b></p> <p>Red = Asbestos      No Asbestos Detected</p>

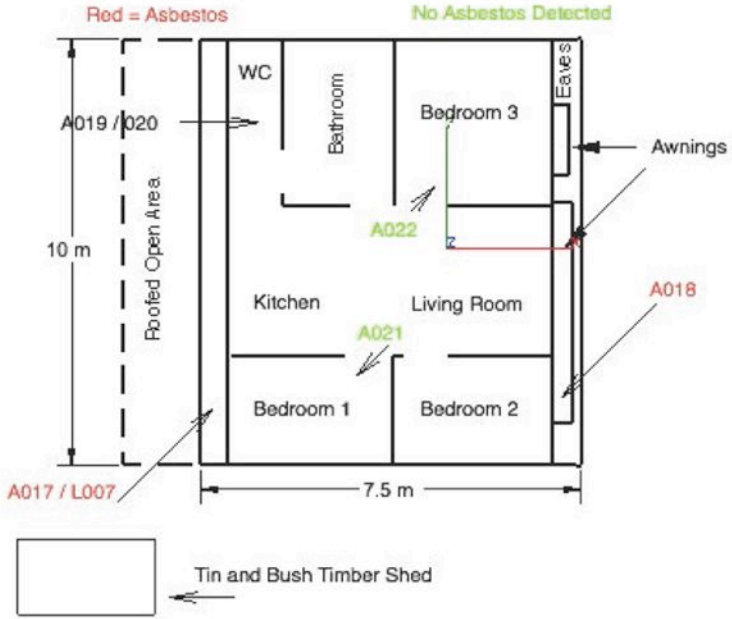
Condition:	Poor	References / Attachments / Comments:					
Fibrous bituminous backed vinyl							
Photo Caption:	A022 Sample Location			Laboratory:	Envirolab Services Pty Ltd

Cert. of Analysis:	110214		
				Lab. Refer:	110214-22		
				Enviroconics Refer:	A022		
				<b>Lead in Paint</b> %w/w <input type="text"/> Area m2: <input type="text"/>			
				Asbestos Detected - Yes: <input type="checkbox"/> No: <input checked="" type="checkbox"/> <b>Asbestos</b> If Detected, What Type: <input type="text"/>			
Sample Description:				Area m2:		16	
Fibrous bituminous backed vinyl							
Asbestos Assessor: Lawrie Lyons (Enviroconics)				Drawings & Illustrations			
<p><b>House 3</b></p> <p>Red = Asbestos      No Asbestos Detected</p>

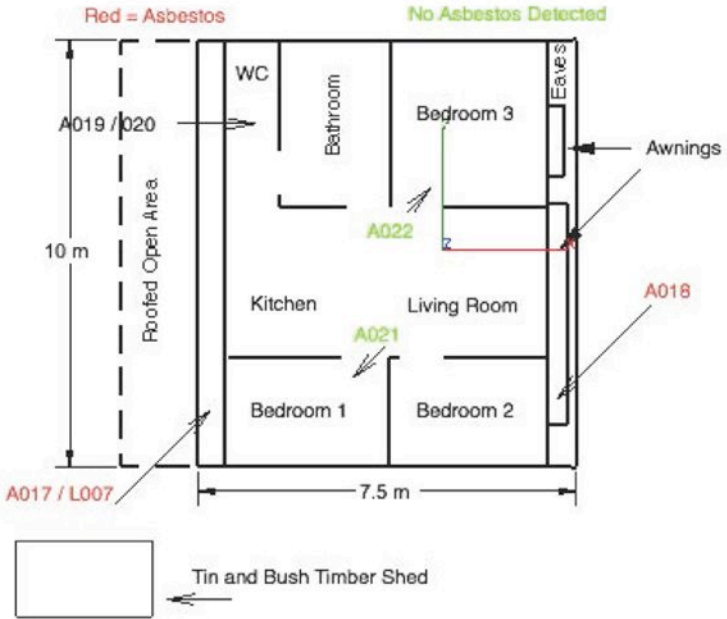
### House 3

References / Attachments / Comments:			
Condition: Poor				Walls and ceilings of house found to be masonite.			
Photo Caption:		Sample Location		Laboratory:		Envirolab Services Pty Ltd

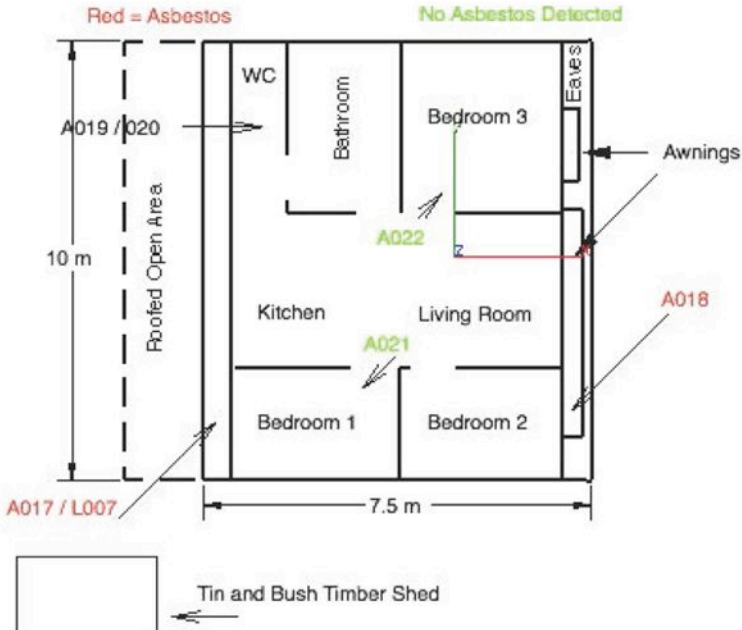
Condition:	Poor	References / Attachments / Comments: The house is extensively painted with the same green paint. A very low concentration of lead detected in the paint.						
Photo Caption:	L007 Sample location		Laboratory: Envirolab Services Pty Ltd

Cert. of Analysis:		110213		<b>Lead in Paint</b> %w/w < 0.05 Area m2: 14
				Lab. Refer:		110213-7		
				Enviroconics Refer:		L007		
				Asbestos Detected - Yes: <input type="checkbox"/> No: <input type="checkbox"/>		<b>Asbestos</b>		
				If Detected, What Type:				
				Sample Description:		Area m2:		14
				Not applicable				
Asbestos Assessor: Lawrie Lyons (Enviroconics)								
Drawings & Illustrations								
<p style="text-align: center;"><b>House 3</b></p> <p style="text-align: center;">Red = Asbestos      No Asbestos Detected</p>
