# **Asbestos Assessor's Report:**

## **TFTA (0233) CF3 P2**

### **Fanning River Integration – COTTAGE THREE**

Environics, 29<sup>th</sup> June 2014 – Environics-rpt-140612-7-rev0

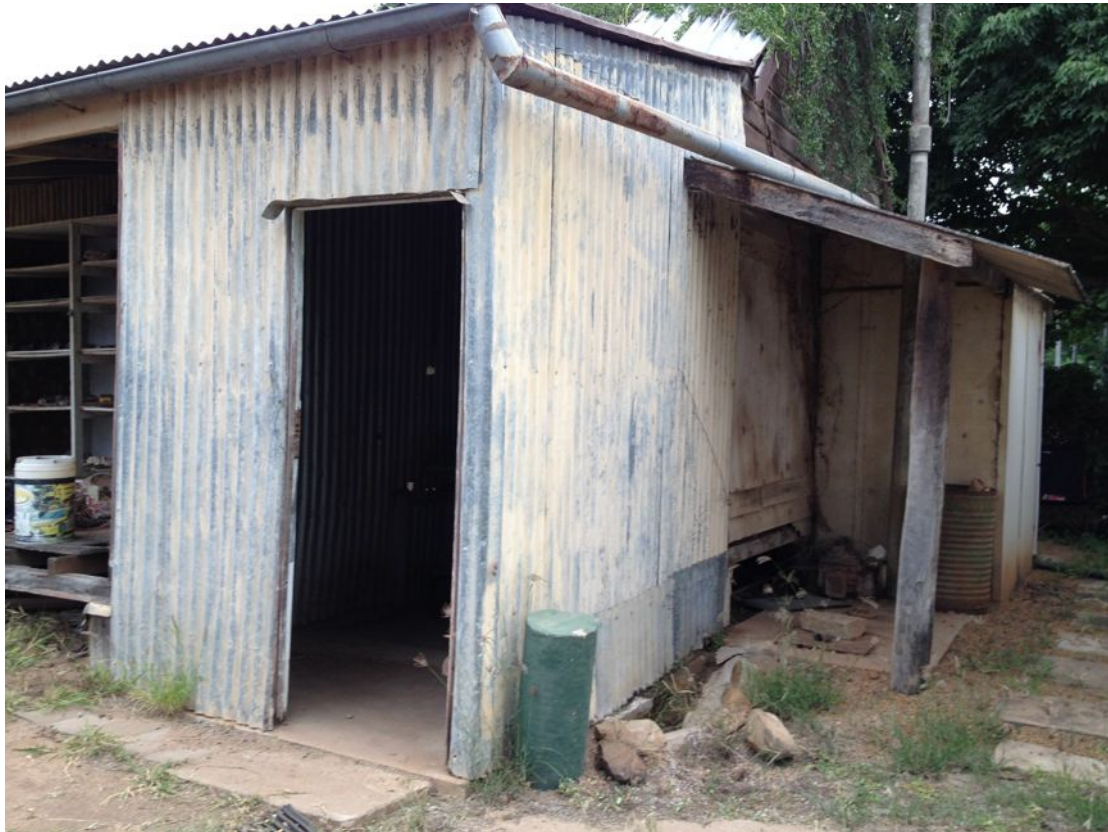
### AHIRs Cottage Three (Asbestos)

| Condition: | Poor | | Chrysotile asbestos detected in lining sheet north internal wall. | | | | | | | | | | | | |

| Condition: | Poor | Chrysotile asbestos detected in lining sheet for shower against western internal wall. | | | | | | | | |

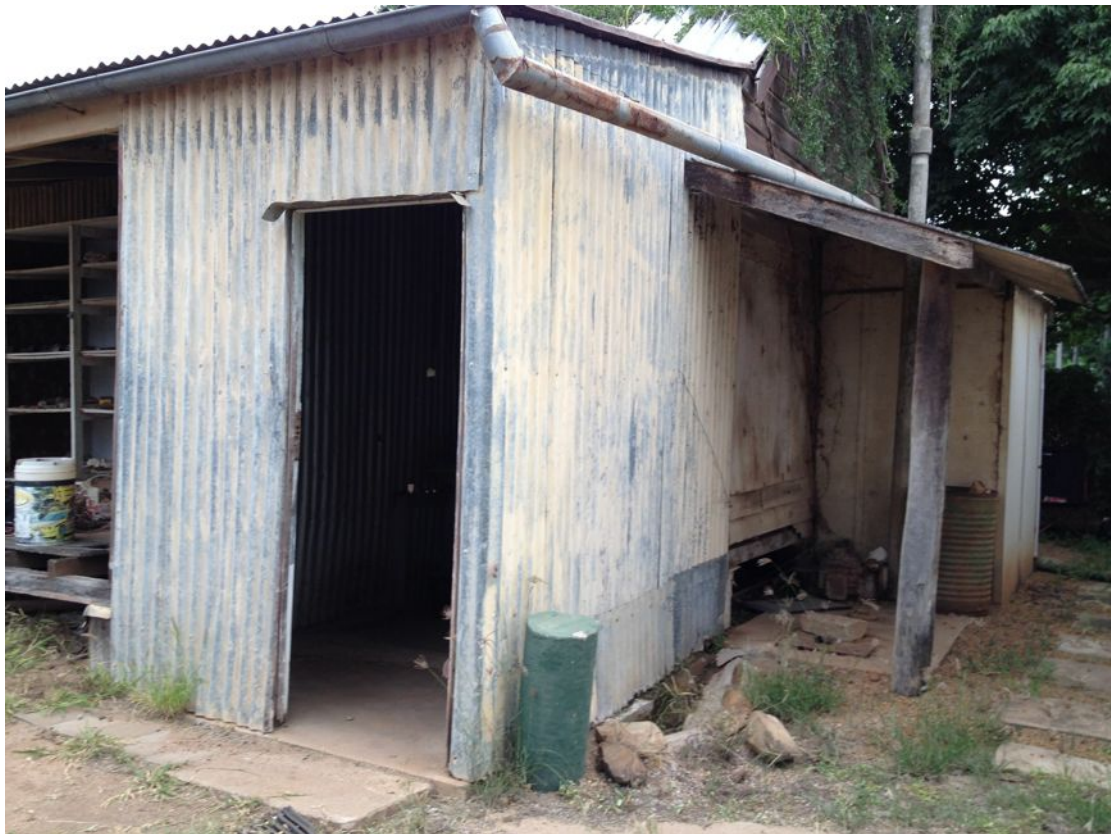
### AHIRs Cottage Three (Lead in Paint)

The subject property is comprised mostly of tin and timber. Much of the paint has gone from the building, however any residual paints on iron panels or timber may be treated as containing a very low concentration of lead on the basis of testing on paints elsewhere of the same colour and physical attributes.
